1. Introduction

29 The research within this paper is based on components postmortem analysis carried out in the
 30 TES-PS10 pilot plant facility built by Abengoa to test the PTC TES systems prior to the design
 31 of commercial projects with this technology [32,33]. The postmortem tests were performed after
 32 more than 30000 hours of operation under representative commercial operation conditions.
 33 Storage fluid analysis is not within the scope of this study, which is focused on the corrosion
 34 performance of storage tanks and pumping systems. Results provide understanding of corrosion
 35 performance of materials typically used for this application and lessons learnt to take into account
 36 for TES systems design to be integrated in PTC facilities at commercial scale.

2 **2. Materials and methods**3 **2.1. TES-PS10 pilot plant**

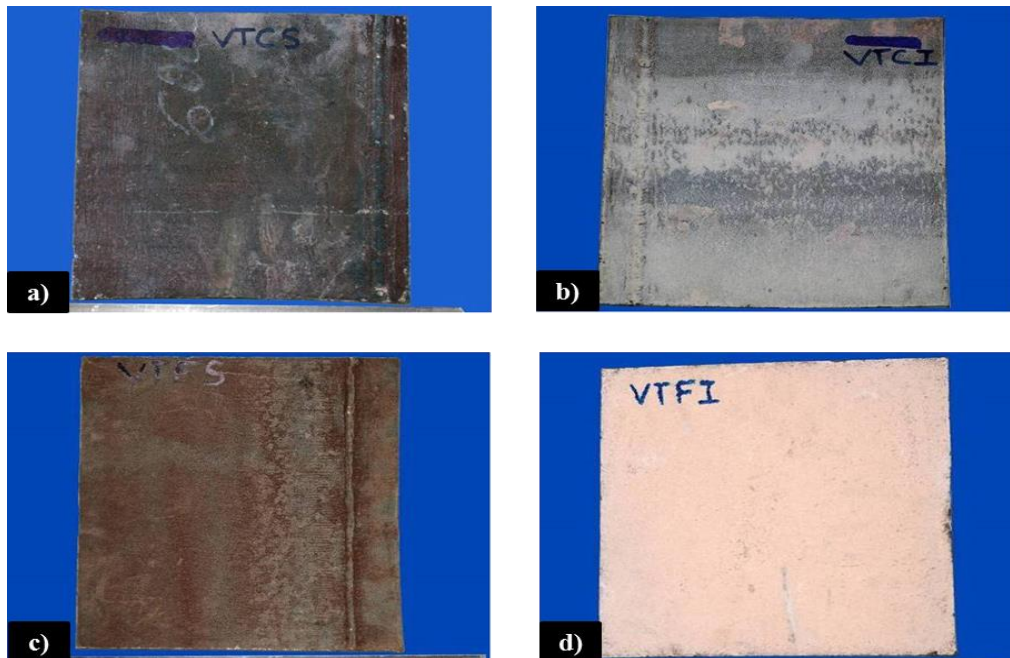
7 **Figure 2. Storage tanks shell sections. (a) upper hot tank (UHT) shell plate section; (b)**
 8 **lower hot tank (LHT) shell plate section; (c) upper cold tank (UCT) shell plate section; (d)**
 9 **lower cold tank (LCT) shell plate section**

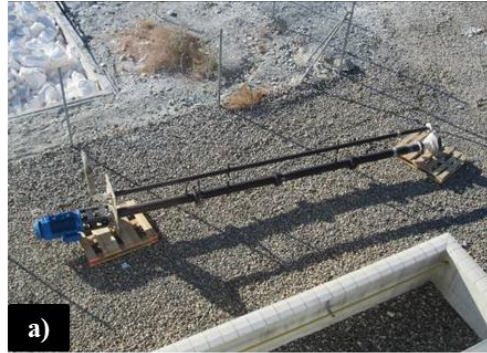
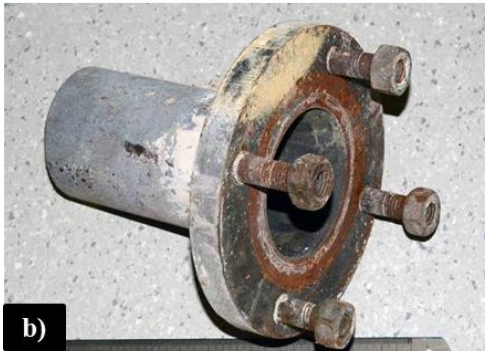
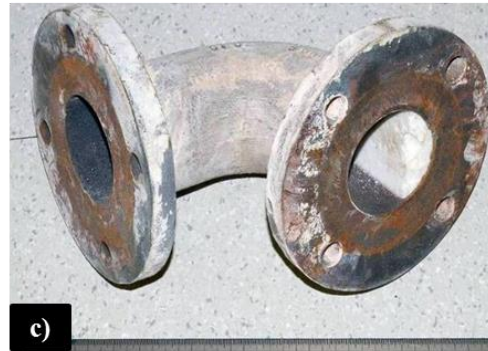
Figure 3. Hot molten salts pump. (a) Molten salts pump removed from the hot storage tank; (b) Discharge pipe section; (c) Discharge elbow section

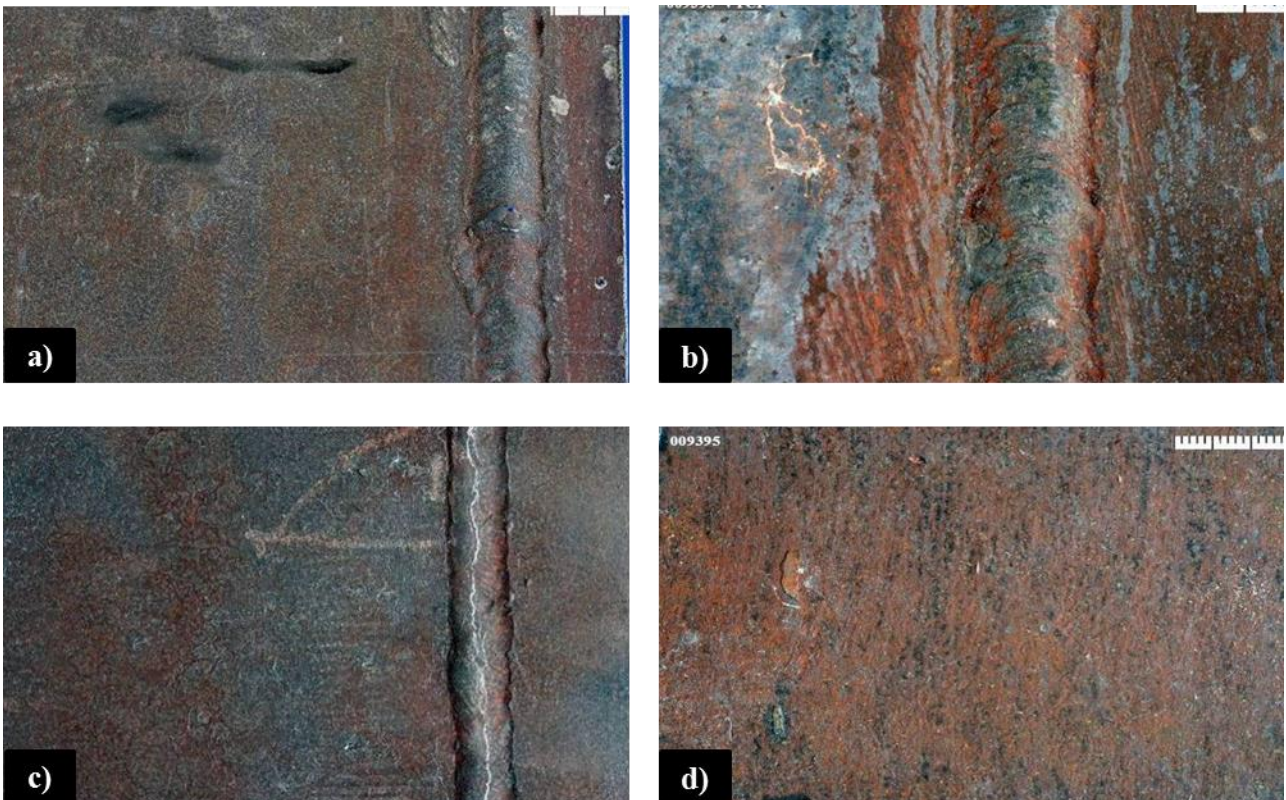
7 Generalized corrosion was observed on the UHT plate surface generating an irregular reddish-
8 brown oxide layer (Figure 4a). The plate showed areas in which the oxide layer was detached as
9 well as small areas with somewhat larger corrosion product generation. These areas were
10 examined more in detail in the SEM/EDS analysis. On the other hand, the LHT plate showed
11 abundant nitrate salt deposits which were partially cleaned using distilled water for a detailed
12 examination of the metal surface. Then, a generalized corrosion could be observed with the
13 formation of a reddish-brown oxide layer, slightly less thick than the one observed on the UHT
14 sample. Corrosion products were also partially detached in some areas (Figure 4b). The UCT
15 plate, Figure 4b, showed a generalized corrosion on its surface with a formation of an apparently
16 compact reddish-brown oxide layer. Finally, the LCT shell section showed a general and fairly

17 uniform corrosion with a reddish-brown oxide layer formation.

19 **Figure 4. Storage tanks shell sections visual inspection. (a) upper hot tank (UHT) shell**
20 **plate section; (b) lower hot tank (LHT) shell plate section; (c) upper cold tank (UCT) shell**
21 **plate section; (d) lower cold tank (LCT) shell plate section**

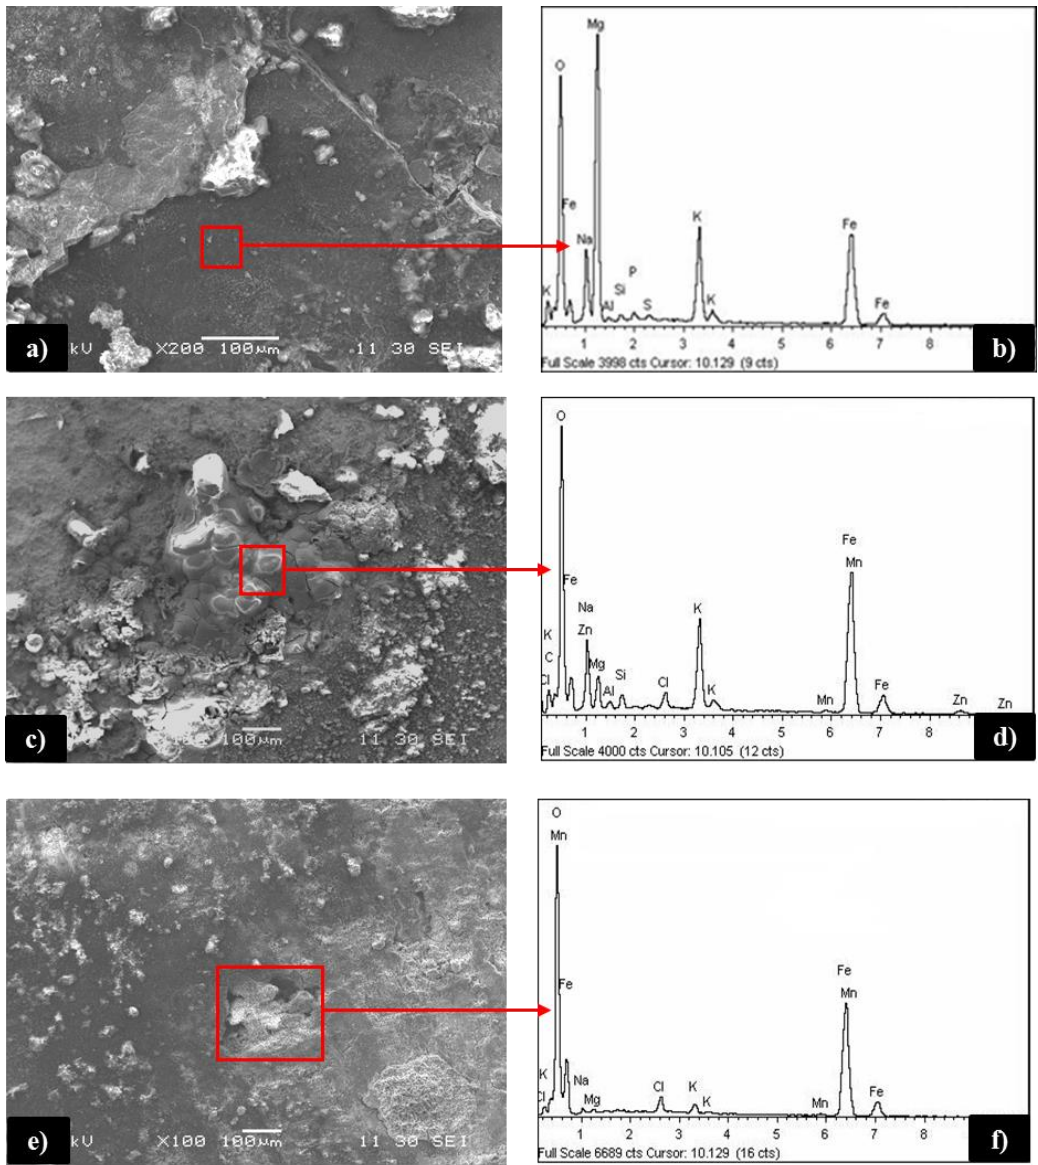
1 Figures 5 includes several micrographs of the corrosion products generated on the surface of the
2 UHT plate. The oxide layer had a certain exfoliating and/or laminating nature in some areas
3 (Figure 5a). EDS spectra associated to this layer indicated that it was basically comprised of iron
4 (Fe) and oxygen (O), as iron oxide, together with significant quantities of sodium (Na), potassium
5 (K) and magnesium (Mg) coming from nitrates salts (Figure 5b). Magnesium is typically in the
6 form of magnesium oxide due to the decomposition of magnesium nitrate which is one of the
7 impurities of sodium and potassium nitrates [34]. SEM micrographs clearly showed the
8 generation of more reddish and voluminous corrosion products in specific areas (Figure 5c). EDS
9 spectra over these corrosion nodules showed chloride not previously detected in addition to iron
10 oxide and nitrate salt residue (Figure 5d). The surface analysis of the LHT plate showed a

11 relatively compact and firmly attached oxide layer, with no evidence of exfoliation unlike what
12 was detected in UHT plates (Figure 5e). Small reddish corrosion spots were also detected in some
13 areas of LHT plates corresponding to micro-areas of localized corrosion. Associated EDS
14 spectrum also showed chloride as one of the elements present in the chemical composition of the
15 corrosion nodule (Figure 5f). On the other hand, Figure 6 displayed different views of the oxide
16 layer generated over UCT and LCT tanks shell sections being the corrosion morphology
17 practically identical for both plates. Micrographs highlighted some areas where corrosion
18 products were detached without exfoliation phenomena (Figure 6a). Sections extracted from cold
19 tank also evidenced micro-areas of localized corrosion (Figure 6b and Figure 6c). Finally, UCT
20 and LCT shell EDS spectra were like ones obtained for hot tank.

Figure 5. UHT and LHT SEM micrographs and EDS spectra. (a) upper hot tank (UHT) section micrograph; (b) upper hot tank (UHT) section EDS spectrum; (c) upper hot tank (UHT) corrosion spot micrograph; (d) upper hot tank (UHT) corrosion spot EDS spectrum; (e) lower hot tank (LHT) section micrograph, (f) lower hot tank (LHT) corrosion spot EDS spectrum

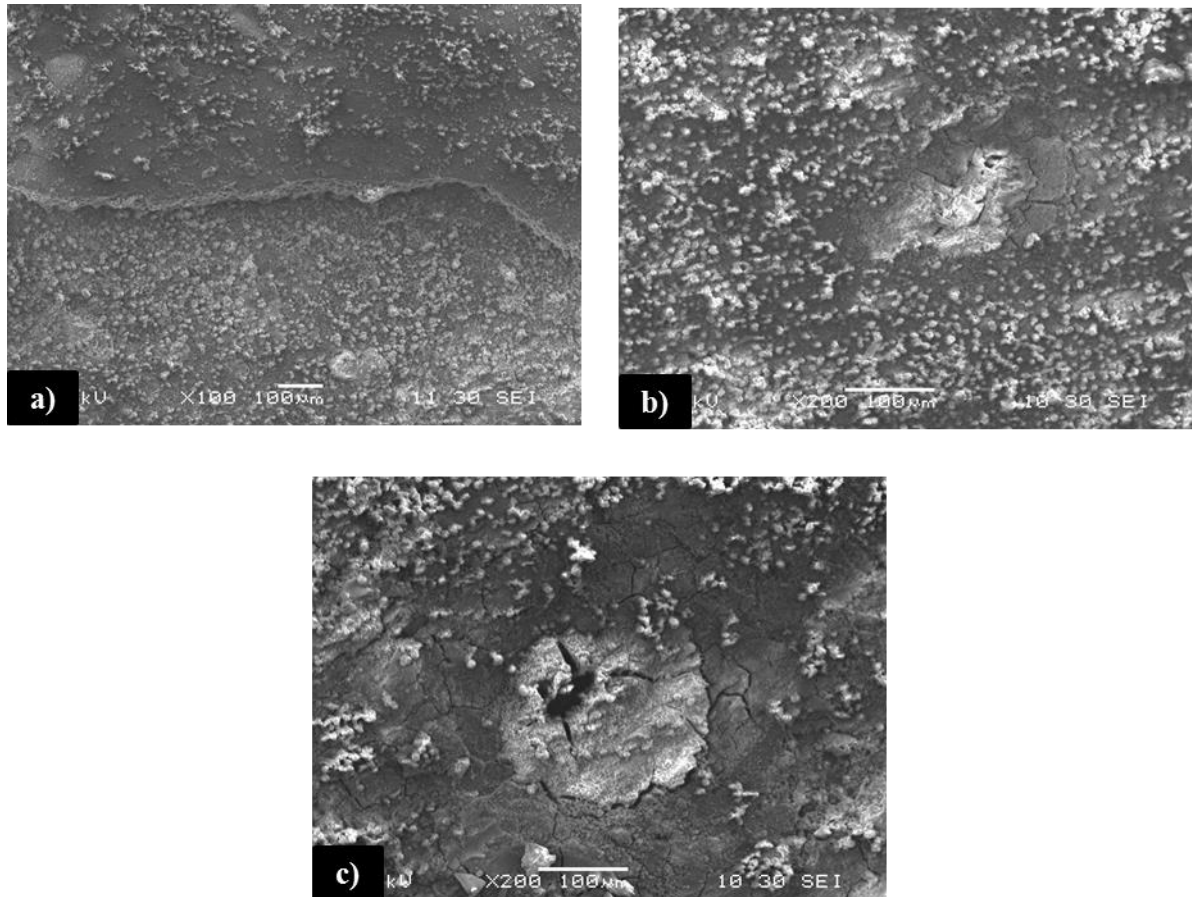
1
2 **Figure 6. UCT and LCT SEM micrographs and EDS spectra. (a) upper cold tank (UCT)**
3 **section micrograph; (b) upper cold tank (UCT) corrosion spot micrograph; (c) lower cold**
4 **tank (LCT) corrosion spot micrograph**

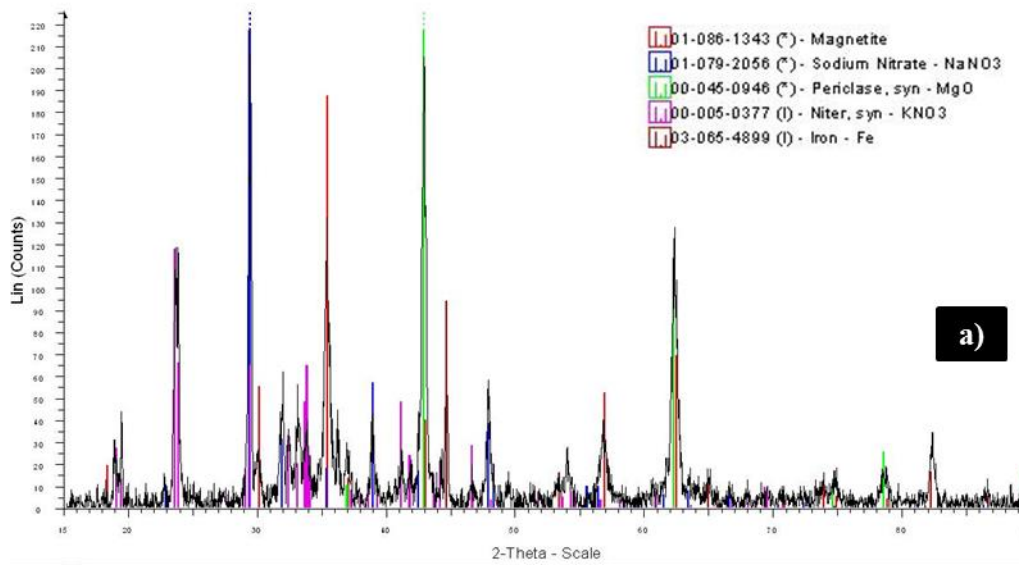
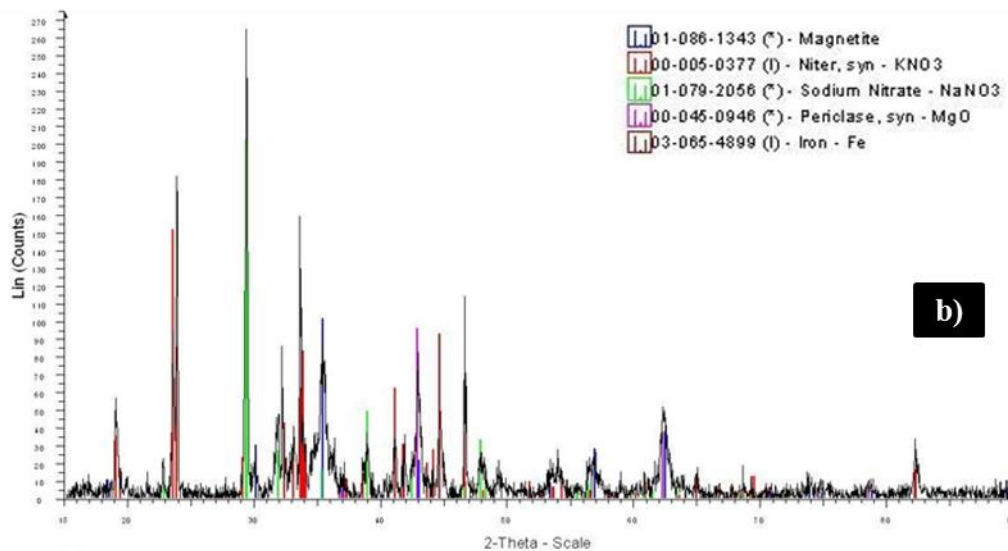
5
6 XRD analysis was carried out over the surface of tank plates. Periclase (MgO) was detected in
7 the XRD spectra which is aligned with EDS analysis showed in Figure 5. As explained before,
8 MgO is produced due to the decomposition of magnesium nitrate and is typically found in the
9 surface of metal components exposed to solar salts [34]. Iron oxide in the form of magnetite
10 (Fe_3O_4) was also detected in XRD spectra. This observation was also found by the authors in
11 previous studies which evaluate the corrosion performance of carbon steel coupons immersed in
12 the storage tanks of the pilot plant under discussion in this manuscript [31]. In addition to MgO
13 and Fe_3O_4 , other species such as NaNO_3 , KNO_3 , and iron was detected in the spectra. This
14 chemistry was similar corrosion products generated in the molten salts pump sections under
15 evaluation. Figure 7 shows XRD spectra for UHT (Figure 7a) and UCT (Figure 7b) as examples

Figure 7. XRD spectra. (a) Upper hot tank (UHT); (b) Upper cold tank (UCT)

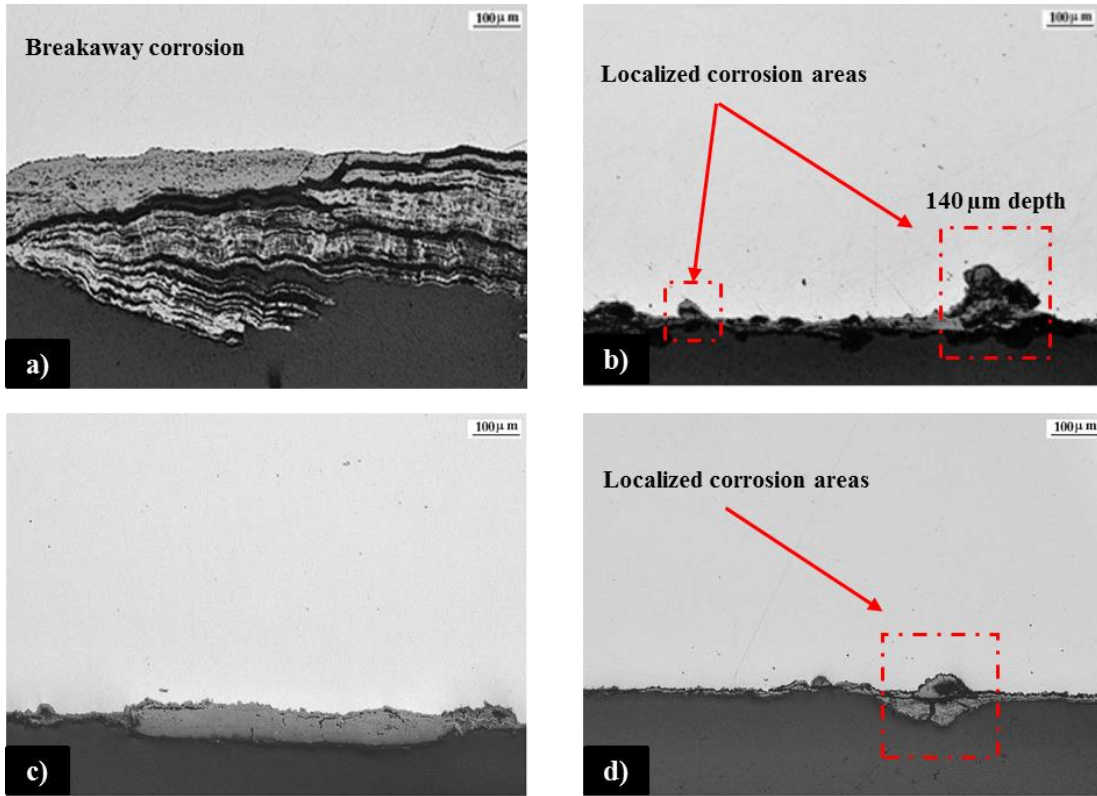
Optical micrograph in Figure 8a showed the oxide scale delamination observed in certain areas on the UHT plate. The small localized corrosion areas (more reddish) detected in the SEM study are shown in Figure 8b. This latter figure shows the maximum penetration depth observed in the different embedded sections of the UHT plate. The corrosion progression through base metal was about 140 microns. Optical micrographs in Figure 8 also show the different morphology characteristics of the oxide layer on the LHT plate. LHT also shows small localized corrosion areas, which barely penetrated the material (Figure 8d). Oxide layer delamination was not observed on this sample. The corrosion morphology and extension on the UCT and LCT samples was practically identical to those observed on the LHT plate section. A partially detached and cracked oxide layer with constant thickness was observed in addition to micro-areas of localized corrosion (Figure 9a and Figure 9b).

1 Corrosion phenomena detected in UHT is typically called as breakaway corrosion being
 2 characterized by non-protective oxide scales. This type of corrosion may occur on carbon steels,
 3 generally at temperatures above 400 °C, although in certain conditions, such as with the presence
 4 of CO₂, chlorides or water vapor on the medium, this phenomenon may happen at lower
 5 temperatures. Thus, in the presence of CO₂, the temperature from which this breakaway corrosion
 6 may be provoked is in the range of 350 °C [35]. Steel parts under this phenomenon are exposed
 7 to higher corrosion rates due to the non-protective performance of corrosion products generated
 8 over the base metal. Conditions under which the preheating of the hot tank was carried out would
 9 be the origin of the non-protective oxides generation in areas intermittently exposed to nitrates
 10 salts. The main goal of tanks preheating was to adequate the metal temperature of the vessel

11 avoiding both, metal thermal shocks during filling and molten salts freezing. Tanks preheating
 12 system was an 850 kW power preheated air blower with propane burner. In addition to metal
 13 temperature increasing prior to salts filling, preheating equipment was also used as a back-up
 14 heating system during the first weeks of operation due to the elevate heat losses higher than
 15 expected and inclement weather during the start-up. Preheating system specification did not limit
 16 the amount of CO₂ introduced inside the tanks so that carbon steel under intermittent exposure
 17 was exposed to the combination of chlorides (coming from molten salts), CO₂ (coming from
 18 preheating system), and water vapor (due to salts hygroscopicity). Taking into account the
 19 corrosion morphology experienced by UHT plates, it is seen that this mixture (CO₂+Cl+H₂O) was
 20 especially aggressive in the hot tank due to higher temperature in this vessel.

21 On the other hand, localized phenomena were developed by carbon steels under all tested
 22 conditions, hot and cold tank in addition to continuous and intermittent molten salts exposure as
 23 previously stated during the evaluation of the metal surface by SEM. This corrosion attack was
 24 not previously detected by the authors in other studies developed with corrosion racks submerged
 25 in TES-PS10 storage tanks nor laboratory tests analyzing the corrosion performance of high
 26 chloride content nitrates salts [29,31]. Within this study, EDS spectra detected the presence of
 27 chloride within the corrosion products being able to take an important role in combination with
 28 storage tanks corrosion atmosphere leading the corrosion mechanism produced in these specific
 29 areas. The main reason for this different corrosion performance in the tanks would be linked to
 30 the exposure time. while the pilot plant was in operation for 30000 hours, corrosion coupons

31 submerged inside the tank were exposed between 1680 and 8712 hours. The higher exposure time
 32 in the tank plates produced the accumulation of chlorides in the localized corrosion areas creating
 33 an accelerated corrosion process in these points. Chlorides concentration increasing was
 34 confirmed by a semi-quantitative EDS analysis of the salt adhered to the plate (Table 3).

Figure 8. Hot storage tanks shell sections micrograph. (a) Oxide scale delamination in upper hot tank (UHT) shell plate section; (b) Localized corrosion in upper hot tank (UHT) shell plate section; (c) Oxide scale in lower hot tank (LHT) shell plate section; (d) Localized corrosion in lower hot tank (LHT) shell plate section

- 13
- 14 • UHT sample showed areas on the internal surface characterized by the growth of an
15 exfoliating/delaminating non-protective oxide scale caused by breakaway corrosion
16 phenomenon. The reason why this attack occurred in the hot storage tank plates exposed
17 to intermittent exposure was due to the combination of CO₂, water vapor and chlorides at
18 high temperature. This mixture was in contact with carbon steel during the preheating of
19 the vessel and later in the first weeks of operation when the preheating equipment was
20 used as a back-up heating system. Because of this result, the design of commercial
21 preheating systems must assure that a minimum amount of CO₂ is introduced during the
22 preheating process to avoid the breakaway corrosion phenomenon.

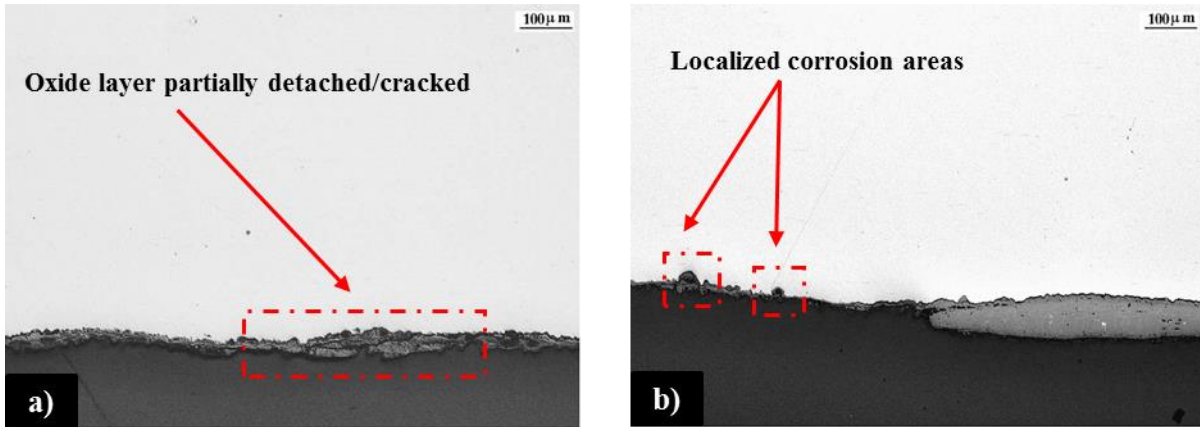
Figure 9. Cold storage tanks shell sections micrograph. (a) Partially detached oxide layer in upper cold tank (UCT) shell plate section; (b) Localized corrosion in upper cold tank (UCT) shell plate section

Localized corrosion nodules were detected for all plates under evaluation (hot and cold tank for continuous and intermittent exposition to molten salts). On the contrary this corrosion damage did not occur in the corrosion coupons. The higher exposition time for tank plates (30000 hours vs. 8712 hours) produced a local chloride concentration increasing generating these corrosion nodules in the material. Chlorides increase molten salts aggressiveness over carbons steels and low alloyed steels due to the formation of chlorine (Cl_2) [36]. Corrosion mechanism is as follows; once chlorine has been produced by de combination of chlorides ions, diffusion processes through oxides layer are

1 produced. Chlorine react with the steel alloying elements to form metal chlorides at the
2 steel/oxides layer interface. Metal chlorides vapor pressure is relatively high at the
3 interface and the evaporation of these species is produced. Then, metal chlorides diffuse
4 back through the alloy oxides layers of the steel. Finally, metal chlorides are oxidized to
5 metal oxides as magnetite and hematite. Then, chlorine is again produced being this
6 specie available to start the process described previously.
7

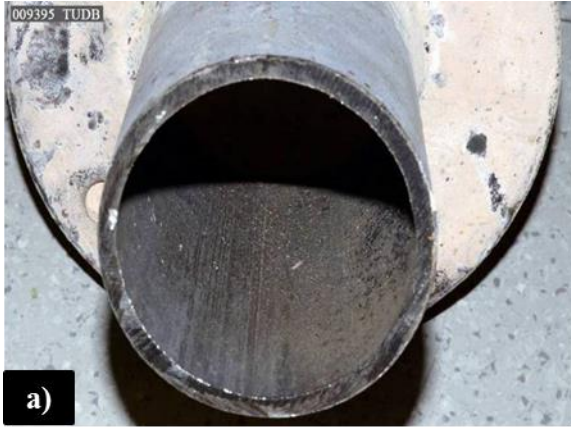
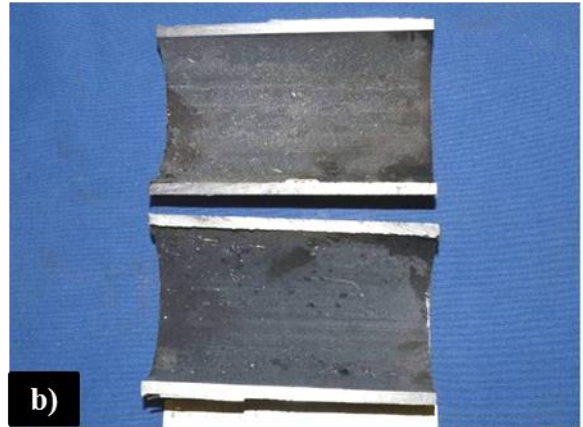
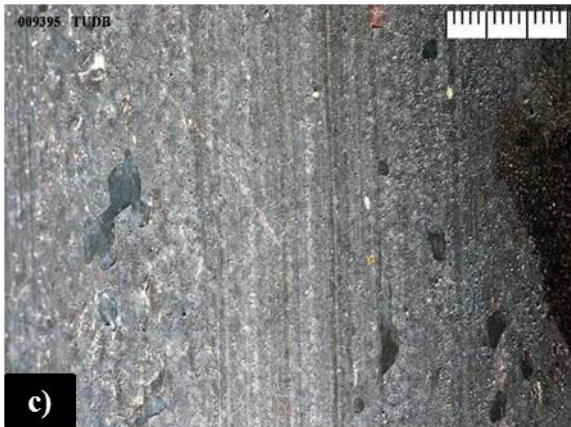
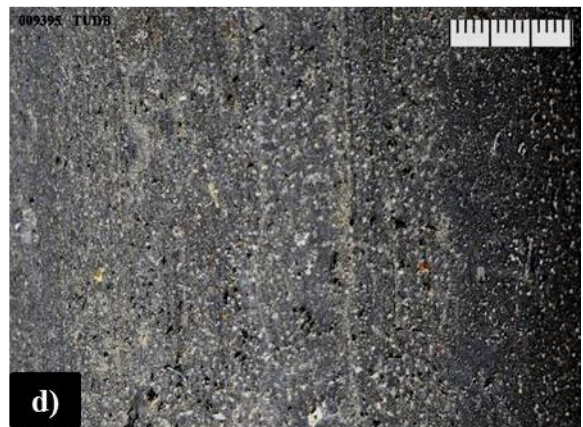
10 Figure 10a shows a photograph of the discharge pump pipe section (DP) after removal from the
11 installation. The external and internal side of this component was continuously exposed to solar
12 salts at an operating temperature in the range of 390 °C. Salt residues were observed on the
13 external surface as well as small areas of reddish-brown corrosion products. A longitudinal dry
14 cut was made in the pipe section in order to examine the internal surface (Figure 10b). A uniform
15 generalized corrosion was observed with a compact and firmly attached blackish oxide layer. In
16 this sense, few small areas showed oxide layer detachment (Figure 10c). The pipe surface next to
17 the flange weld showed small corrosion particles or aggregates, probably due to the corrosion of
18 particles or contaminants generated during the welding of the pipe to the flange. Localized
19 corrosion on this component was not detected (Figure 10d). On the other hand, Figures 11 shows

Figure 10. Discharge pump (DP) sections visual inspection. (a) DP overall detail; (b) Dry cut over DP section; (c) DP internal section detail; (d) DP internal section detail in an area close to nozzle joint

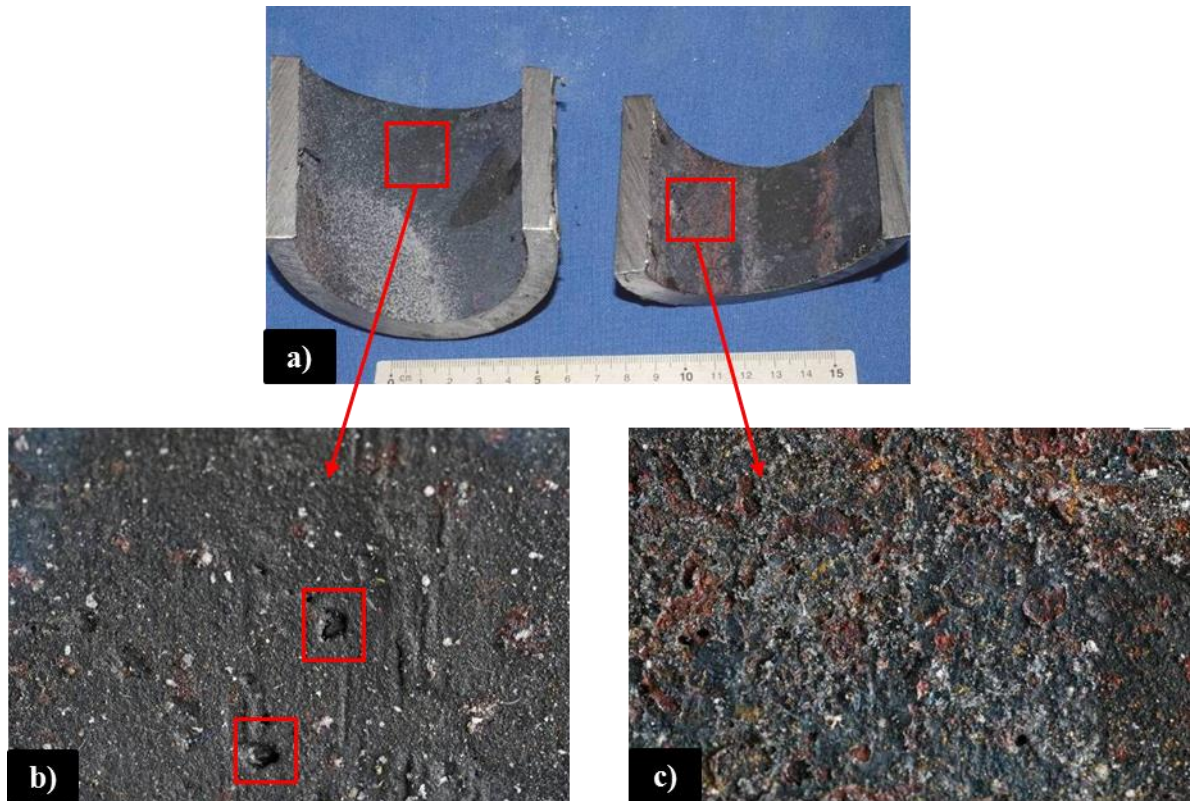
20 different details of the discharge elbow (DE) section. The external surface kept most of the
21 original paint, although there was evidence of salt residue and areas with slight generalized
22 corrosion. The DE section was also cut for a detailed analysis of the internal surface (Figure 11a).
23 In general, a compact adherent blackish oxide layer was present in most of the internal surface.
24 However, some reddish corrosion spots on top of the initial blackish oxide layer could be observed
25 (Figure 11). Several pores or cavities are detected on the internal surface (red rectangles in Figure
26 11b).

2 **Figure 11. Discharge elbow (DE) sections visual inspection. (a) Dry cut over DE section;**
 3 **(b) DE internal section highlighting cavities; (c) DE internal section highlighting reddish**
 4 **corrosion spots**

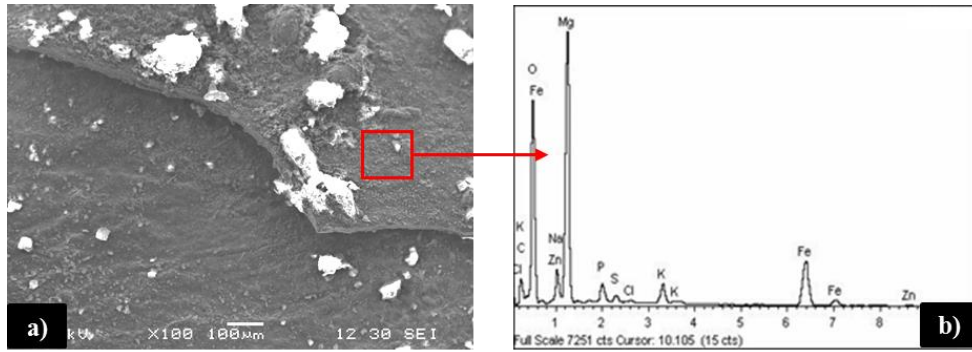
7 The internal surface of the pipe was examined by SEM-EDS for a detailed analysis of the
 8 corrosion products generated in the metal surface characterizing chemical elements involved in
 9 the oxides layers. The electron micrograph in Figure 12a shows a detail of the internal surface of
 10 the DP section. The oxide layer was partially detached in some areas. The EDS analysis of this
 11 layer indicated that it was basically comprised of Fe and O, as iron oxide, together with significant
 12 quantities of Na, K and Mg as constituents of the nitrate salts (Figure 12b). The DP external
 13 surface showed a similar morphology to that found on the internal surface. In this case, the
 14 original coating layer was cracked in several areas (Figure 13a). Beneath this cracked layer, the
 15 pipe surface looked rusted. The EDS analysis conducted on the painted surface detected a
 16 significant amount of the salt residue. The presence of calcium (Ca), copper (Cu), and aluminum

Figure 12. Discharge pump (DP) internal surface micrograph and EDS spectrum. (a) DP internal surface SEM; (b) DP internal section EDS spectrum

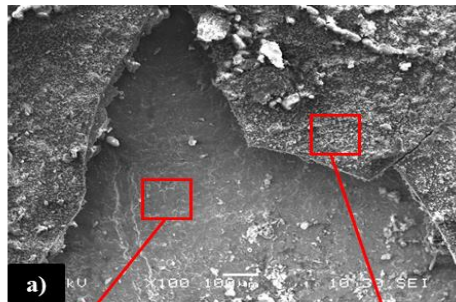
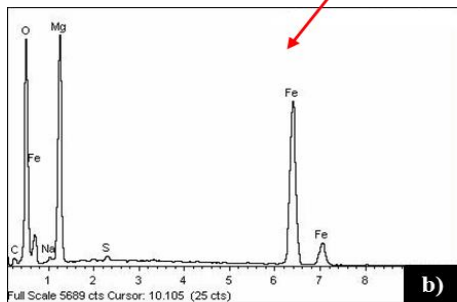
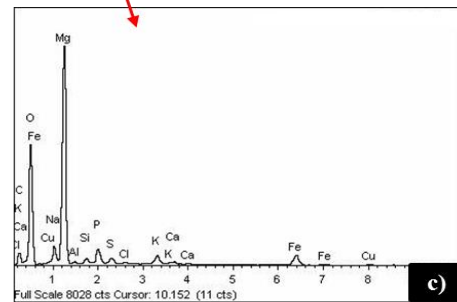
17 (Al) on the coating would be associated to the paint itself (Figure 13c). The appearance of the
 18 internal surface of DE sample in a pore-free area is shown in Figure 14a. The electron micrograph
 19 showed a thin and compact oxide layer over the base metal. The micrograph in Figure 14c showed
 20 the aspect of the micropores observed on the internal surface of the component in Figure 11b.
 21 Finally, EDS spectra were in agreement with previous profiles analyzed within this study in
 22 previous components (Figure 14b and Figure 14d).

Figure 13. Discharge pump (DP) external surface micrograph and EDS spectra. (a) DP external surface SEM; (b) DP external surface EDS spectrum (below coating); and (c) DP external surface EDS spectrum (coating)

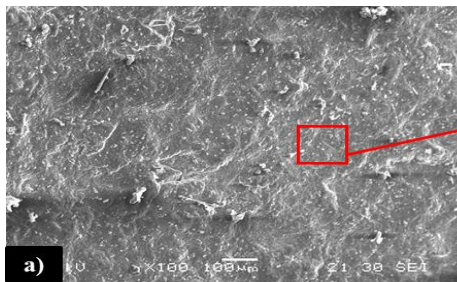
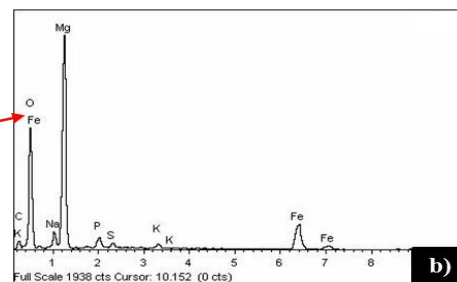
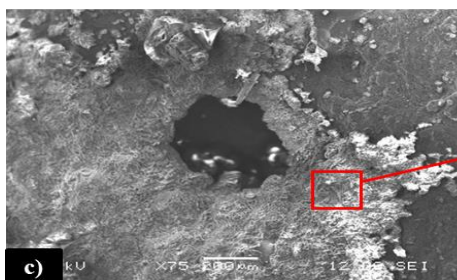
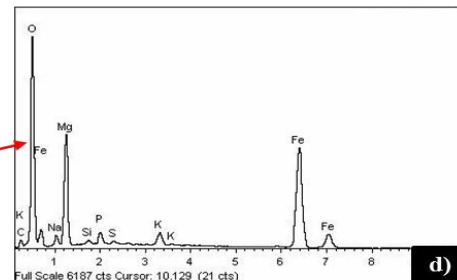
1 **Figure 14. Discharge elbow (DE) internal surface micrograph and EDS spectra. (a) DE**
2 **free-cavities area SEM; (b) DE free-cavities area EDS spectrum; (c) DE cavity SEM; (d)**
3 **DE cavity EDS spectrum**

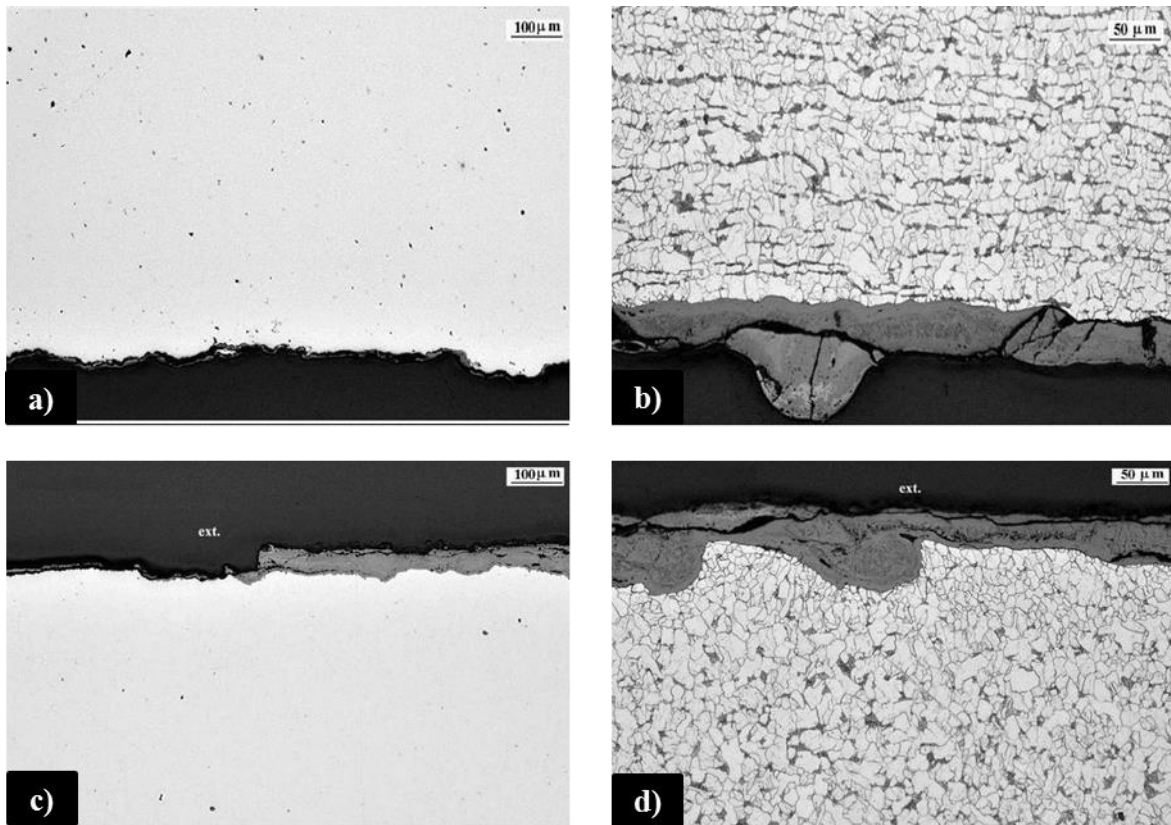
6 Metallographic specimens were prepared from transversal sections extracted from the DP sample
7 under evaluation to be analyzed by using optical microscopy. The internal surface of DP section
8 had an almost uniform and firmly attached oxide layer (Figure 15a). The external surface showed
9 a similar corrosion to that observed on the internal one. In this way, corrosion products were
10 similar in thickness and shape in zones where coating was practically removed (Figure 15c). DP
11 sample showed a ferrite-perlite microstructure which is typical of in carbon steels (Figure 15b
12 and Figure 15d). Transversal sections were also cut from DE sample for microstructural analysis.
13 Then, Figure 16a shows the internal surface detecting a very well adhered and thin oxide layer.
14 Micro-pores discussed in previous sections are shown in Figure 16b and Figure 16c being mostly
15 located on the internal surface of the elbow. The size of these cavities was variable, being able to

19
20 **Figure 15. Discharge pump (DP) sections evaluation. (a) DP internal surface; (b) DP**
21 **internal surface microstructure with metallographic etching; (c) DP external surface; (d)**
22 **DP external surface microstructure with metallographic etching**

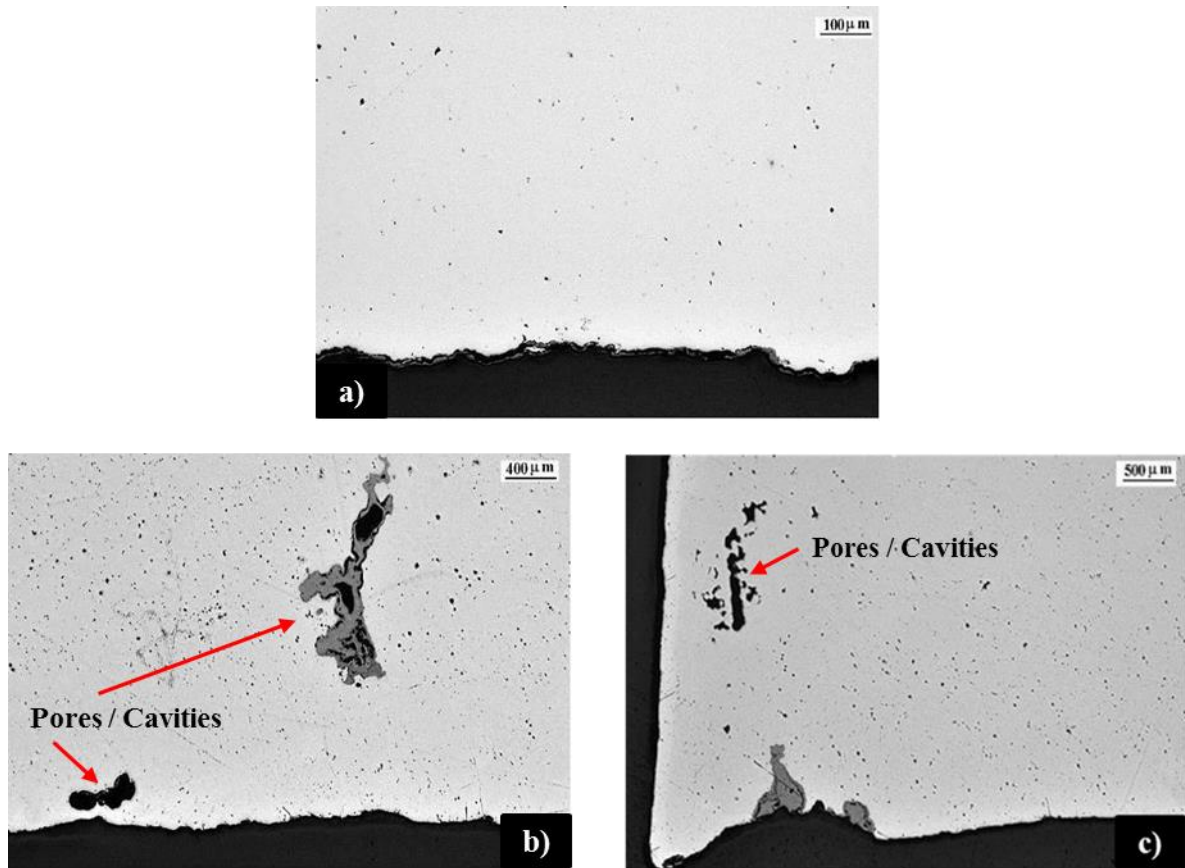
16 reach up to 1 mm in size. Accordingly, the metallurgical quality of the cast steel was not the most
17 suitable because of many pores were observed in the original material.

1
2 **Figure 16. Discharge elbow (DE) section evaluation. (a) DE internal surface; (b) and (c)**
3 **DE internal surface highlighting cavities**
4

- Metallurgical quality of the cast steel was deficient detecting many pores/cavities in the original material. The possible coalescence of these cavities could lead to an unexpected failure of the component for long-term expositions. An exhaustive quality control over sections manufactured by casting processes must be carried out to avoid in service failures.
