Cement remnants removal in implant restorations: A preliminary *in vitro* study

Treball de final de grau

**UNIVERSITAT DE
BARCELONA**

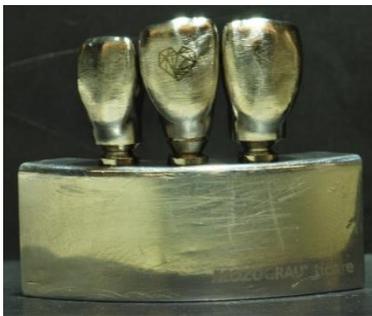
Figure 4. Study template with 1.1, 2.1 and 2.2 crowns (buccal view).

An aluminium template made with Computer-Aided Design/Computer-Aided Manufacturing (CAD/CAM) technology (Mozo-Grau, Valladolid, Spain) was employed in the present *in vitro* study. This template included 3 implant analogues separated by a 3 mm margin. The replicas were 1.5 mm apart from the buccal and lingual/palatal margin (Annex Figures 1, 2, Annex Table 2). These three analogues represented implants in the following positions: 1.1, 2.1 (test) and 2.2. Two screw-retained crowns were fabricated for the mesial and distal implants (1.1 and 2.2) (Annex Figure 3, Annex Table 2), and 9 identical cement-screw restorations were made using a 1-mm-height polished abutment for the centrally positioned implant 2.1 (Figure 1). A combined screw and cement retained crown design (Figures 2, 3) was chosen in order to allow unscrewing the entire crown-abutment complex without touching the cement remnants. The adjacent restorations (1.1 and 2.2) were added to the template to mimic a more realistic clinical scenario with interproximal areas. Both, 1.1 and 2.2 crowns were screw-retained again to facilitate the removal of the test restoration without affecting the cement excesses (Figures 4, 5) (Annex Figure 4).

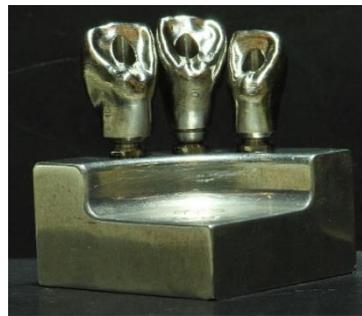
Figure 5. Study template with 1.1, 2.1 and 2.2 crowns (palatal view).

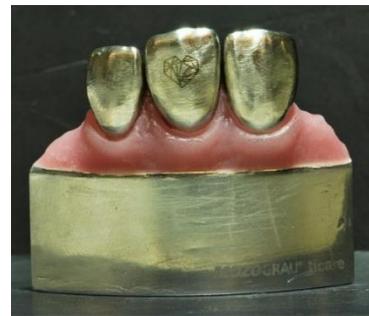
Figure 6. Study template with artificial gingiva (buccal view).

An artificial polyvinylsiloxane gingiva (GI-MASK automix®, Coltene, Altstätten, Switzerland) was fabricated by a dental technician (Fco. Javier Fernández SL. Dental prosthesis laboratory, Barcelona, Spain) by means of a wax-up (Figure 6). Crowns margin were placed in 1 mm subgingival position. One gingiva replica was used for each sample to avoid damage by use.

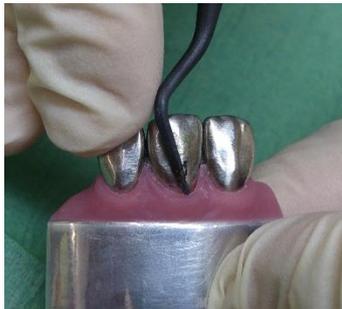
Figure 15. Cement excess removal with a teflon scaler.

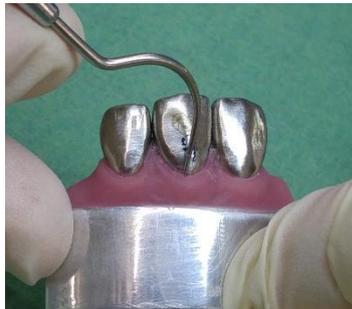
Figure 16. Cement excess removal with a stainless steel explorer.

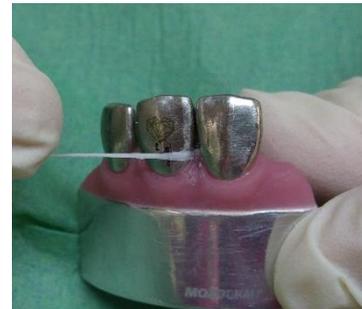
Figure 17. Cement excess removal with waxed dental floss.
