The Avalanche of Les Fonts d'Arinsal (Andorra): An Example of a Pure Powder, Dry Snow Avalanche

Abstract: On 8th February 1996, in the north-western part of Andorra in the Pyrenees, the Les Fonts d'Arinsal (LFd'A) pure powder avalanche was triggered, descending some 1200 m to the bottom of the Arinsal valley and continuing up the opposite slope for about 200 m. This size 4–5 avalanche reached velocities of up to 80 ms^{−1}, devastated 18 ha of forest, involved a minimum volume of up to 1.8 × 10⁶ m³ and caused major damage to eight buildings. Fortunately, no one was injured thanks to an evacuation, but 322 people lost their properties. This study describes the physical characteristics of the LFd'A avalanche path and provides data on earlier avalanches, the meteorological synoptic situation and snowpack conditions that generated the avalanche episode, the warning and preventive actions carried out, the effects and evidence of the large avalanche, and the defence system implemented afterwards. A discussion of the avalanche dynamics based on observations and damage, including the role of snow entrainment, the total lack of characteristic dense flow deposits, as well as the evidence of

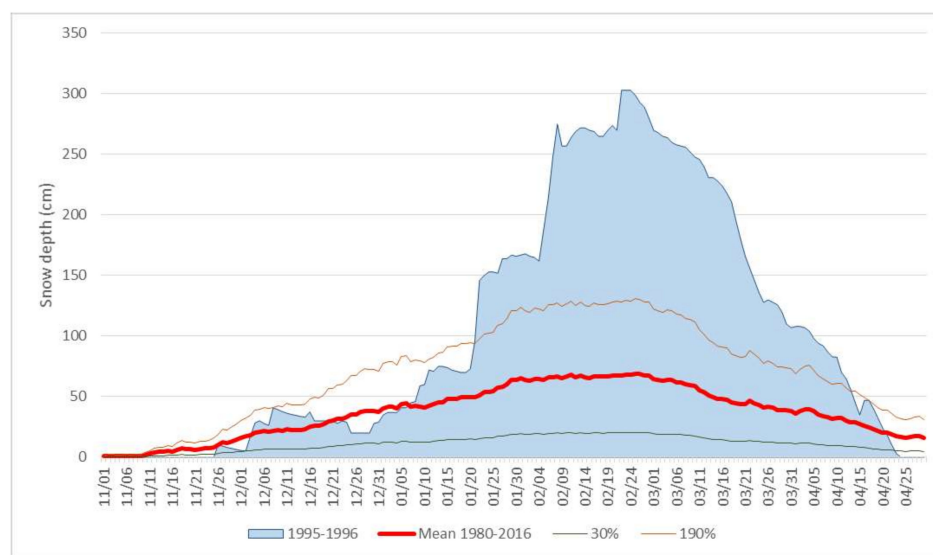
Figure 4. Blue polygon shows the daily snow depth (cm) data recorded at the manual weather station in Arinsal ski resort (1927 m a.s.l.) during the winter season, from 1st November 1995 to 30th April 1996. Red, green and brown lines correspond, respectively, to the mean, 30% and 190% values of snow depth (cm) for the 1980–2016 reference period. Gaps in the long-term daily snow depth series have been reconstructed by means of the Safran–Crocus reanalyses generated within the framework of the CLIMPY 2016–2019 project.

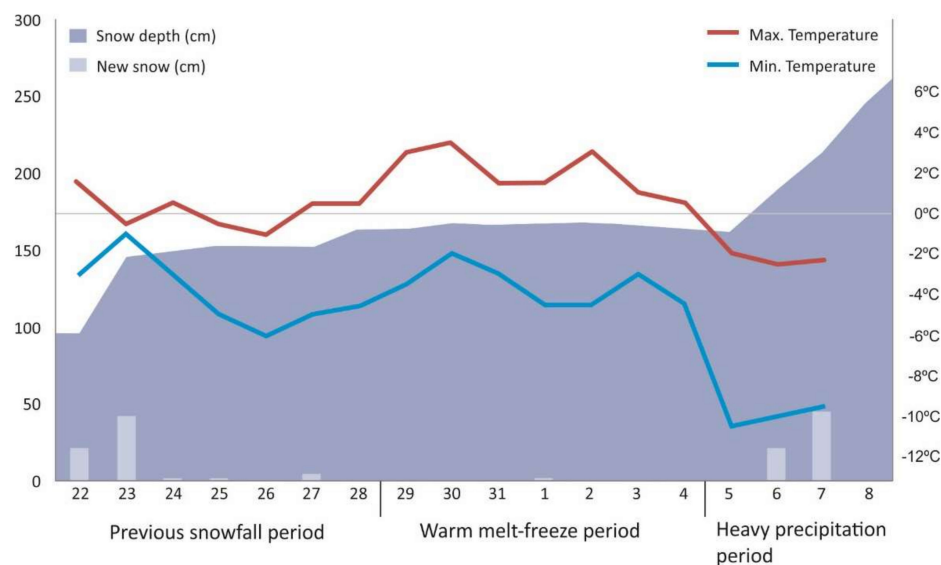
Figure 5. Snow depth (cm), new snow (cm) and minimum and maximum daily temperatures from 22nd January to 7th February 1996, observed at the manual weather station at the Arinsal ski resort (1927 m a.s.l.).

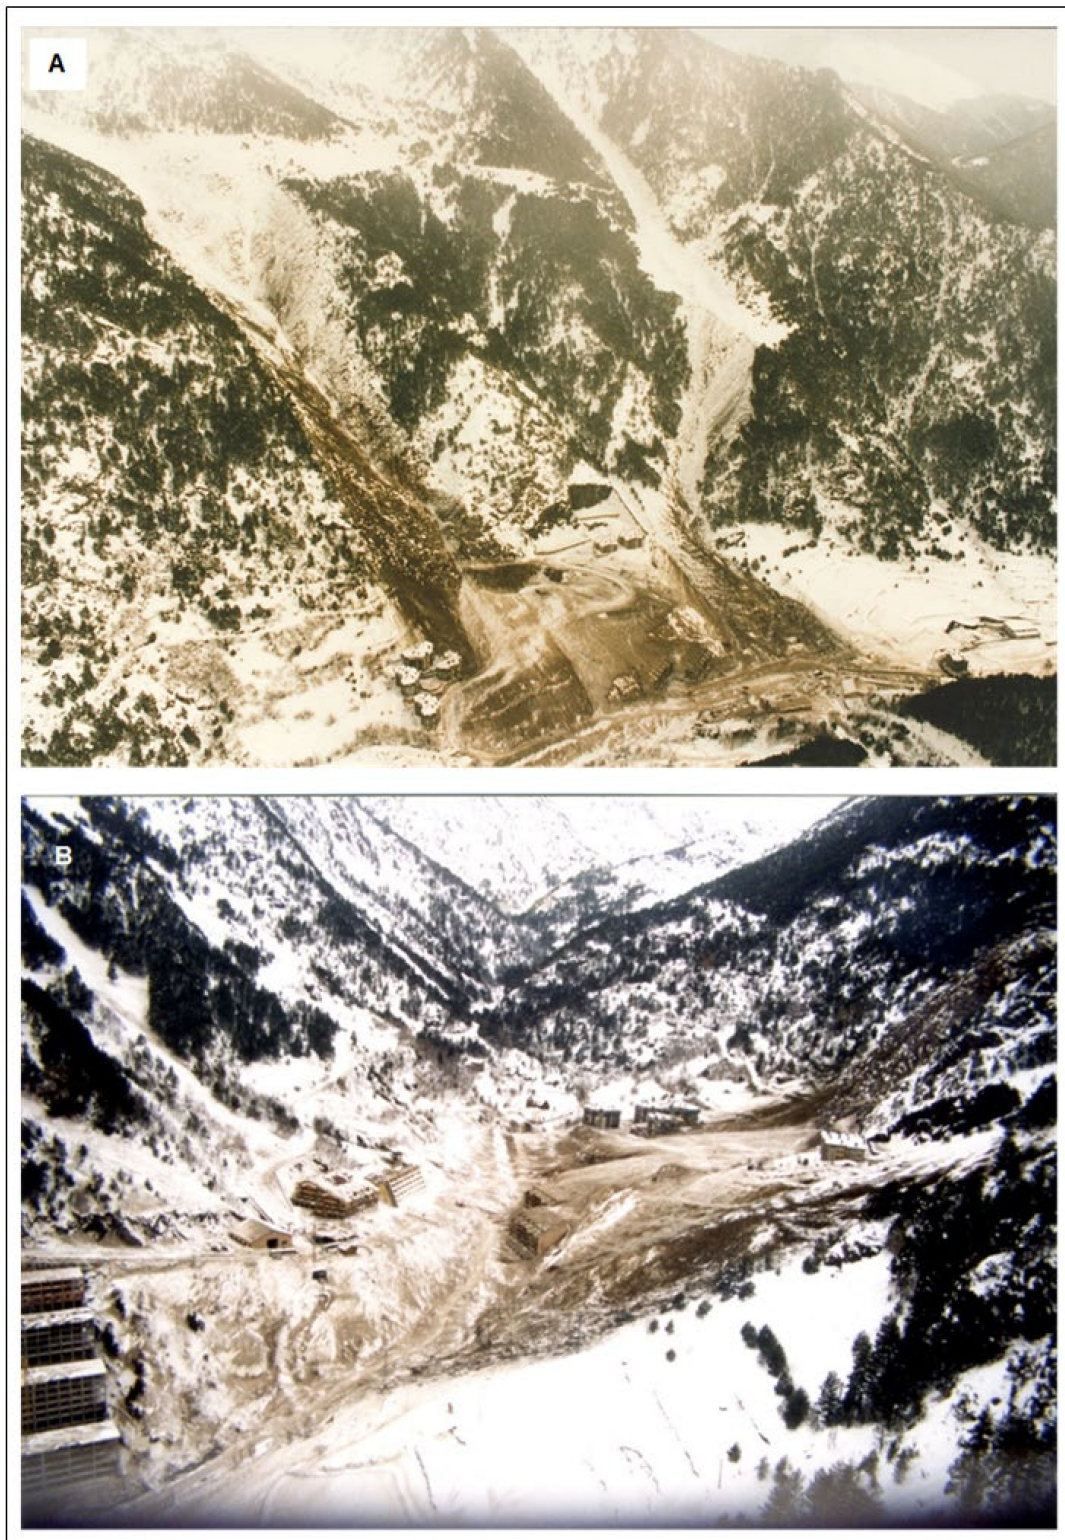
Figure 7. Photographs taken from a helicopter the day after the avalanche (Dept. d'Indústria). (A) track and run-out zones of Les Fonts (left) and Percanela (right) avalanches; the LFd'A avalanche entrained the whole snowpack in the track zone, completely destroying the forest and partially eroding the soil; (B) run-out zone view from downstream to upstream in the main valley; the main aerosol trajectory direction can be observed in the plastered snow on the ground.

The LFd'A avalanche of 8th February descended about 1200 m. following a straight trajectory along the track zone (Figure 1, Figure 7A, Figure 8A), climbed up the opposite slope for about 200 m (Figures 1 and 7B) and then turned downstream towards Arinsal village for approximately 1 km (Figures 1 and 8B). It appeared as a dirt-brown cloud, accompanied by a loud noise that was heard all the way to the centre of the village, and was described as being “like a bomb”, at Mas Ribafeta, about 1500 m down the valley. The dominant winds during the snowfall blowing from the north and north-west eroded the snowpack on the slopes adjacent to the cirque ridge. Thus, the SE to SW basin orientation favoured overaccumulation of the drifted snow (Figure 3). The crown height of the released slab was estimated at between 1.1 and 1.5 m. The minimum snow volume released and involved in the avalanche ranged from $1.5 \times 10^6 \text{ m}^3$ (rapidly estimated by the experts in 1996) to $1.8 \times 10^6 \text{ m}^3$, according to release area drawings and a few helicopter observations made a couple of days after the avalanche and through GIS analysis. The whole cirque was considered as the starting zone for these estimations, as no stauchwall could be identified. Moreover, snow was entrained all along the track. In a rough estimation, the mass involved in the avalanche may have ranged from $300 \times 10^6 \text{ m}^3$ to $550 \times 10^6 \text{ m}^3$. The avalanche velocity was estimated by technical experts to be over 300 kmh^{-1} (or approximately 80 ms^{-1}) [15].

At the LFd'A avalanche path, the new, cold snowpack covered the entire slope and bottom of the valley. No measures or estimations of snow entrainment could be made, although the volume of new snow entrained must have been huge. In the cirque, it was impossible to distinguish the main released area from the area with entrained snow: no stau wall observations were reported, nor could any be derived from the photographs. No secondary slab releases feeding the avalanche, as described by Köhler et al. [22], could be identified. Due to the quality of the snow and the angle of the slopes at the top of the path, between 40° and 45°, it is most likely that some small, dry snow avalanches descended to the bottom of the cirque on the two preceding days (6th and 7th February) and the deposits were entrained by the large avalanche of 8th February [7]. The released volume, estimated roughly, must have included the main cirque snowpack. Certainly, entrainment occurred all the way along the avalanche's descent up to the slope rupture at the valley floor (1600 m a.s.l.) and even further downwards. Below the cirque, where no previous snowpack existed, visual observations corroborate that all the available new snow deposited since 6th February was entrained into the avalanche (Figure 7A, Figure 8A).

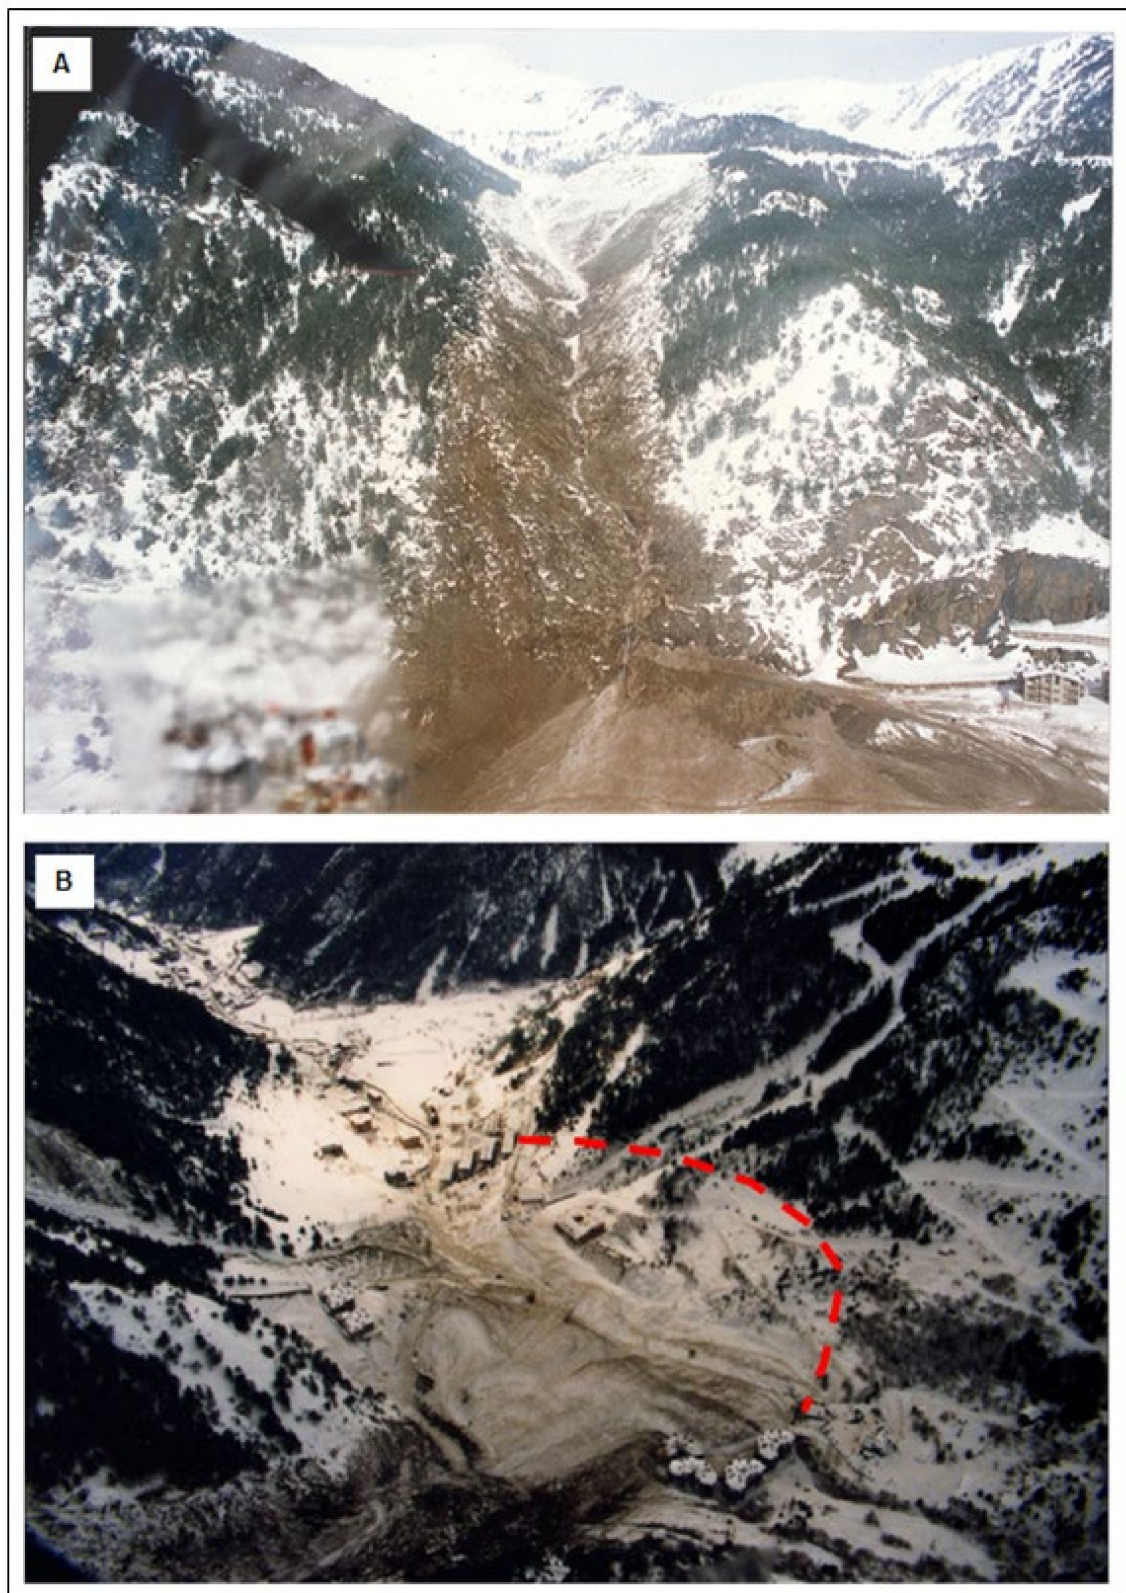
Figure 8. Photographs of the avalanche showing (A) the LFd'A track zone after the pure powder avalanche of 8th February 1996 (photo: A. Reyes); (B) the run-out zone, whose destructive limits can be mostly mapped by observing the damaged forest (red dashed line) (photo: Dept. d'Indústria).

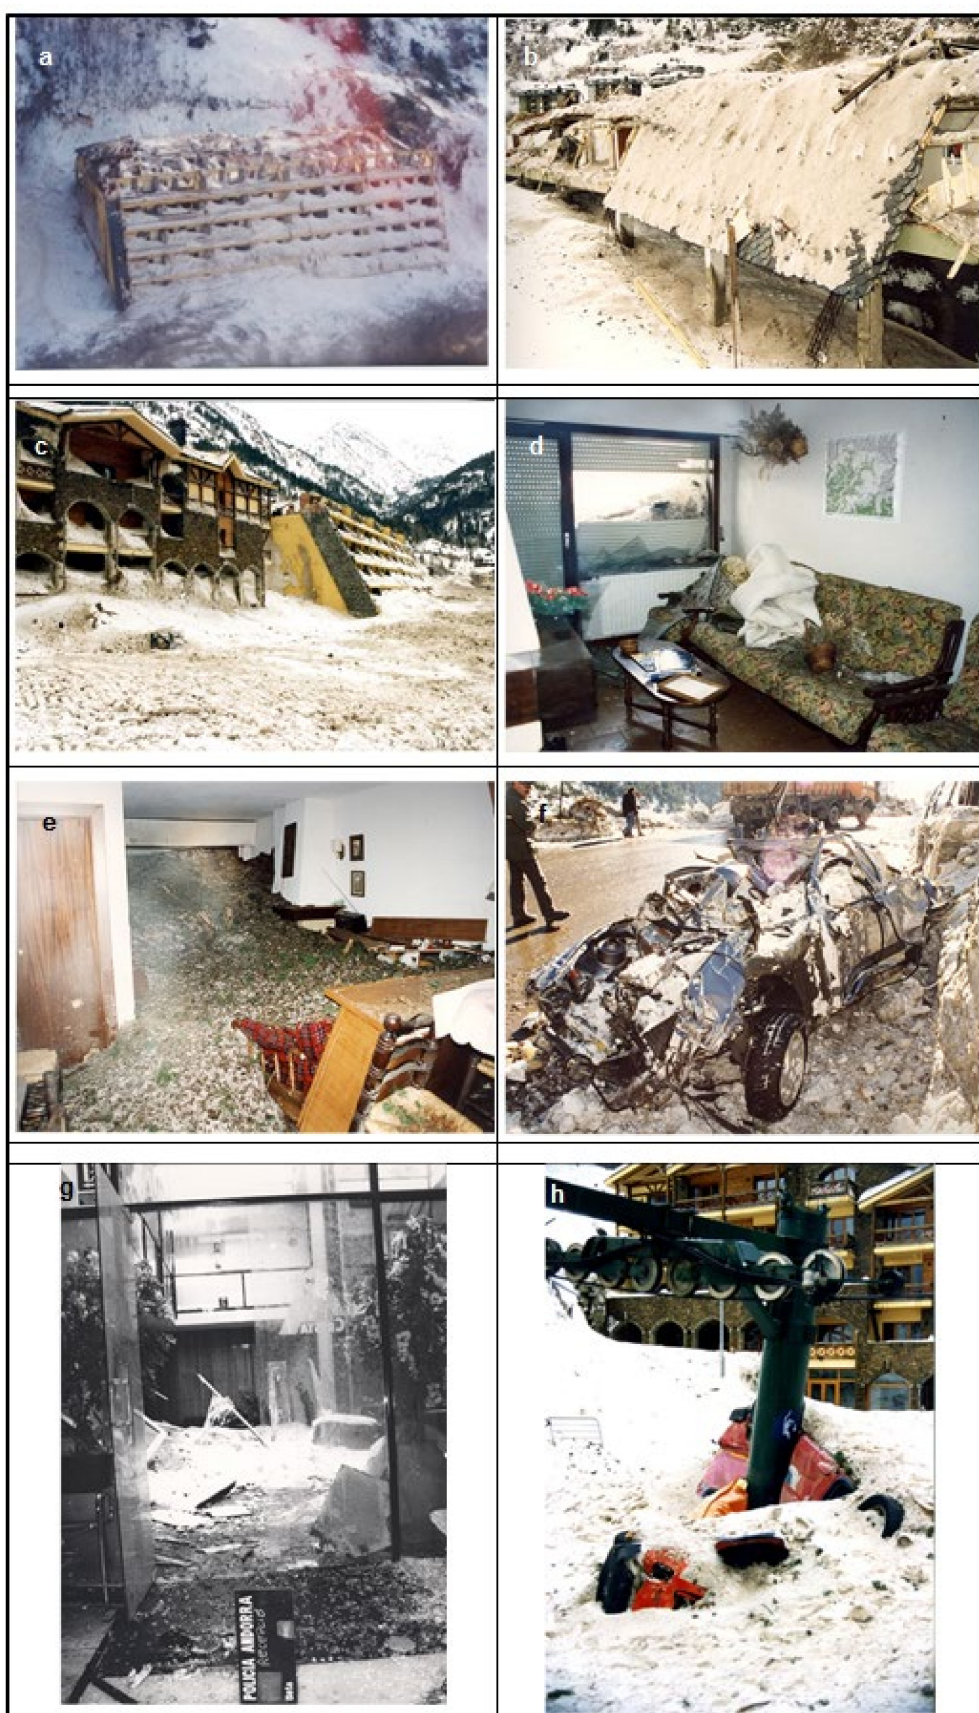
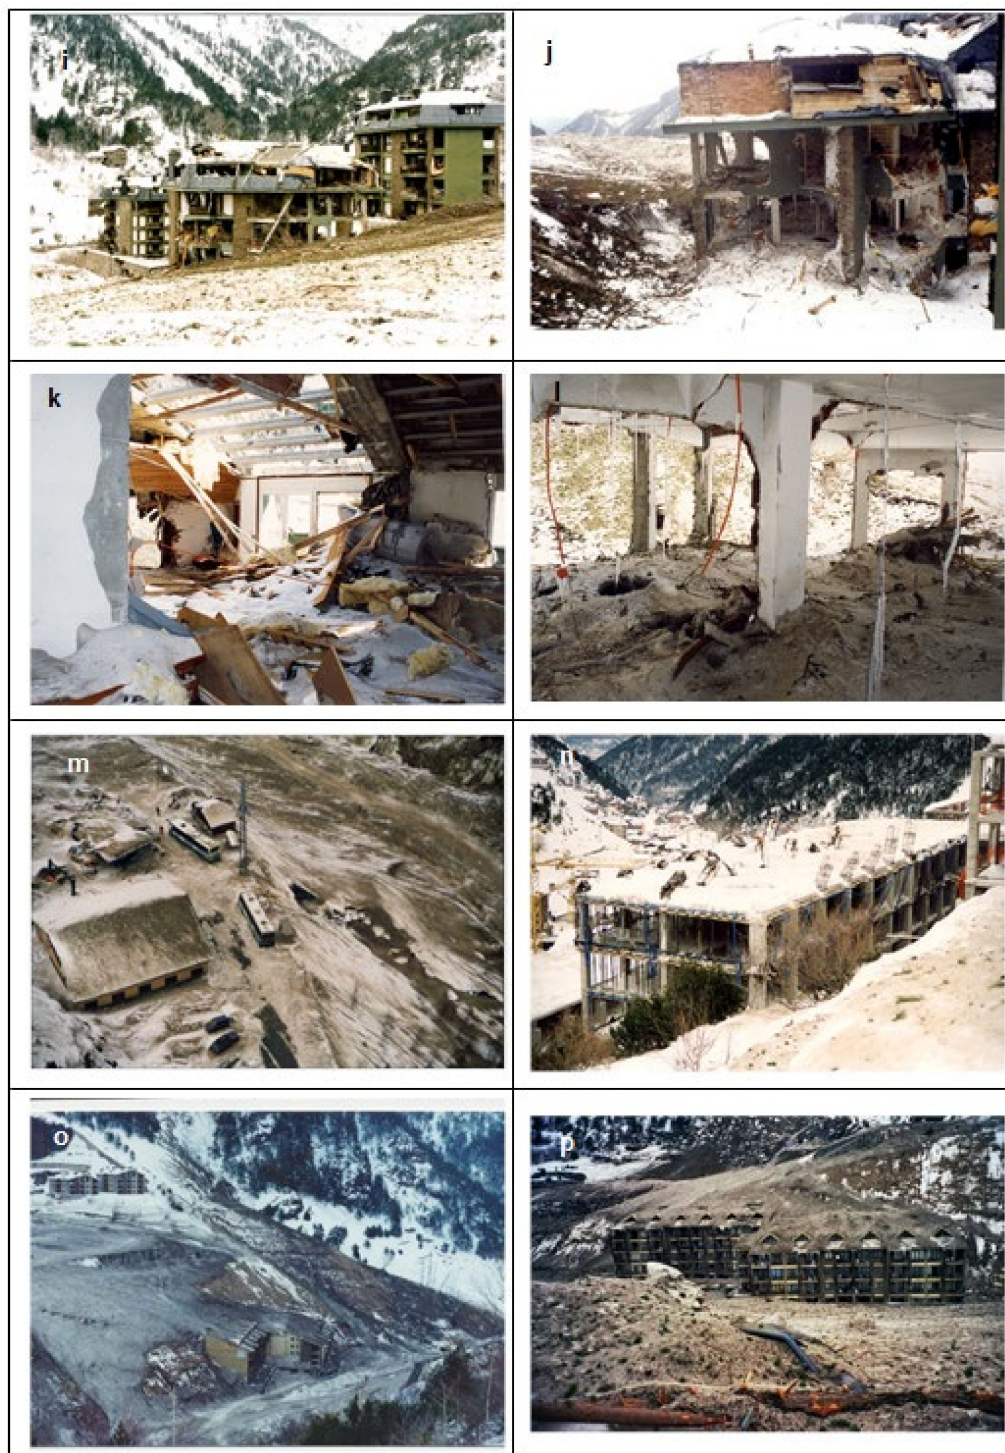
Figure 10. Cont.

Figure 10. Pictures of damage in the run-out zone: (a) Peu de Pistes (PdP) building with the roof lifted and destroyed; (b) PdP building with the roof lifted and destroyed displaced backwards; (c) PdP and Crest Hotel with plastered snow filling the ground floor; (d) PdP apartment with window glass broken; (e) PdP apartment filled with dirt snow; (f) car smashed in front of PdP; (g) Crest Hotel roof skylights burst; (h) van wrapped around a chairlift pylon; (i) Prat Sobirans (PS) buildings destroyed; (j) PS D block with structural damage; (k) PS D block, top apartment, roof and partitions destroyed; (l) PS D block, ground floor; (m) aerial view of the ski lift area, the bottom right-hand corner points to the Astra complex; (n) Astra complex building in construction, protruding parts of the reinforced concrete's iron rods bent by the aerosol blow; (o) run-out slope, Velvet and Amadeus blocks; (p) Amadeus buildings.

The avalanche crossed the river and ran uphill, hitting the Peu de Pistes and the Crest Hotel (Figure 10c). It entered the Peu de Pistes building directly through the ground floor, lifted the entire first floor slab to the second floor, filling both levels with dirt snow (Figure 10e) (the slab descended slowly during the snow melt) [2], exiting through the sixth floor lifting part of the roof and displacing it to the back of the building and destroying the rest (Figure 10a,b) [15]. Most of the windows burst (Figure 10d) [2]. At the Crest Hotel, the avalanche also entered through the ground floor, clogged the ground floor and staircase and left by bursting the roof skylights (Figure 10g). In front of these two buildings, about 40 cars parked in the parking lot were smashed (Figure 10f), mostly by being crushed against the buildings; some even ended up inside the Peu de Pistes bar [14,15]. The smashed cars were

filled with snow so hard that it was impossible to insert a knife into the deposits. A van was wrapped around a chairlift pylon (Figure 10h) and another car was lifted to the roof of the chairlift station [15]. The compacted dirt snow deposit at the parking lot surpassed 4 m in height (consistent with the ground floor clogging of Peu de Pistes and Crest Hotel buildings). Due to its high density and hardness, it had to be removed mechanically by bulldozers. Further down, at the Astra complex buildings (now the Ribasol Residencial), under construction at that time, the protruding parts of the reinforced concrete's iron rods were bent by the aerosol blow (Figure 10n). About 300 m downwards, a man gripped onto the wall of a house so as not to fall (Figure 9); he thought an avalanche (not the LFd'A event) was coming from the east-facing slope, thus confirming that the avalanche turned downwards towards the valley. Traces of the turn of the avalanche can be clearly observed in Figure 10m.

Clear evidence of pressure depression related to the avalanche descent can be seen in the Amadeus buildings (Figure 9o,p, Figure 10), where windows facing downslope were opened outwards and curtains were found hanging outside. This depression could have been caused by the step effect

In Prat Sobirans and Peu de Pistes, the main damages and snow clogging affected two storeys of apartments. In Prat Sobirans, the two most seriously affected floors were in block D (Figure 9i–l, Figure 10) at ground level. In the avalanche path run-up, the lower two floors of Peu de Pistes and the Crest Hotel (Figure 9a,c, Figure 10) were the most affected, especially in the first building, where these two floors were filled up with snow. This, as well as the 4 m of snow piled up in the parking lot in front of these buildings, suggests that the denser part of the LFd'A avalanche might have had a height similar to these two floors, which would correspond roughly to the ~5 m thick transition zone, as defined by Ancey [21], the fluidised layer of Gauer et al. [23] and Issler et al. [24] or, more precisely, to the intermittent frontal region defined by Sovilla et al. [17] and Köhler et al. [22]. Thus, the fluidised flow height would be around 5–6 m. The high densities of these deposits (see Section 5) are in accordance with the density of the fluidised flow deposits measured by Issler et al. [24] in the giant avalanche of 1995. The frontal air blast injected into the buildings produced the overpressure which burst the roof and skylights.

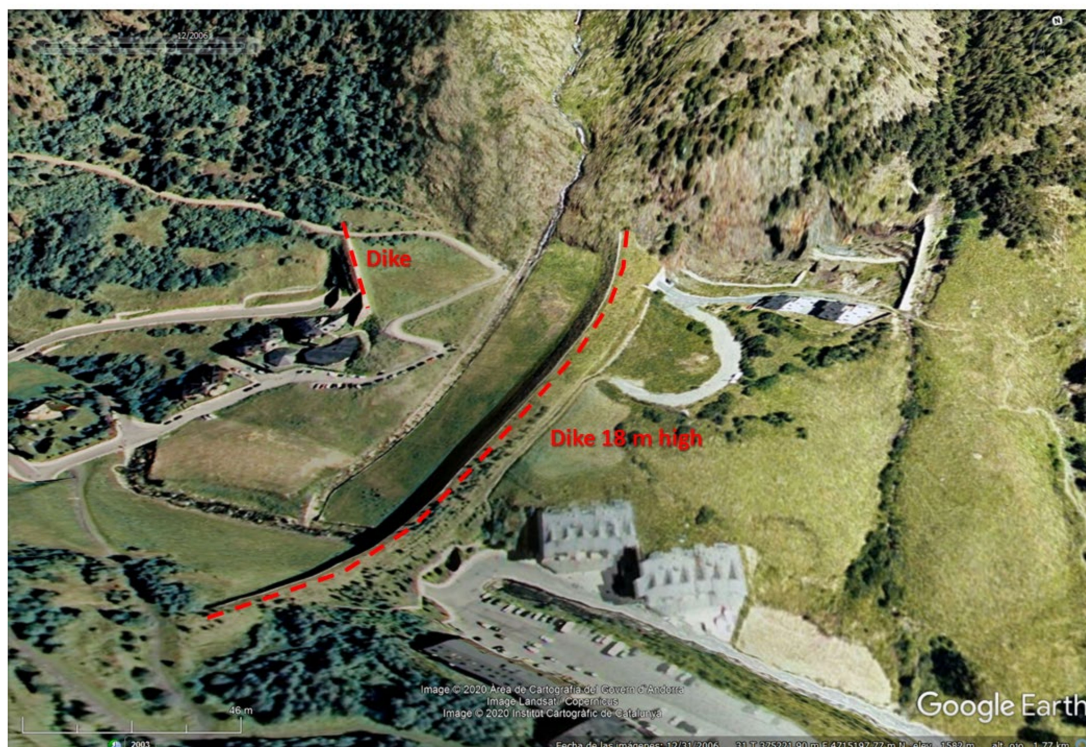
Figure 11. System of dikes in the run-out zone of Les Fonts d'Arinsal avalanche path.

In the run-out area, an 18 m high dike with a flat area upstream was built, designed to hold back the denser part of the avalanche and to deflect the aerosol. The overall aim is to protect the infrastructures located below (the parking area, buildings and lower chairlift of the ski station, Amadeus apartments, Patagonia building, Velvet building, Crest Hotel and Astra complex) from the direct impact of the avalanche. A smaller dike in the opposite part of the run-out area was constructed to protect block C of the Prat Sobirans apartments and the access to the Velvet building (Figure 11). Most buildings were reinforced, and the structure of the Prat Sobirans block D was modified with the removal of three flats.
