Archaeological and Anthropological Sciences
GEORADAR INVESTIGATIONS IN THE CENTRAL NAVE OF HAGIA SOFIA,
ISTANBUL (TURKEY)
 --Manuscript Draft--

GEORADAR INVESTIGATIONS
IN THE CENTRAL NAVE OF HAGIA SOFIA, ISTANBUL (TURKEY)

Key words: Hagia Sofia, georadar, urban archaeology, architecture, laser scanner

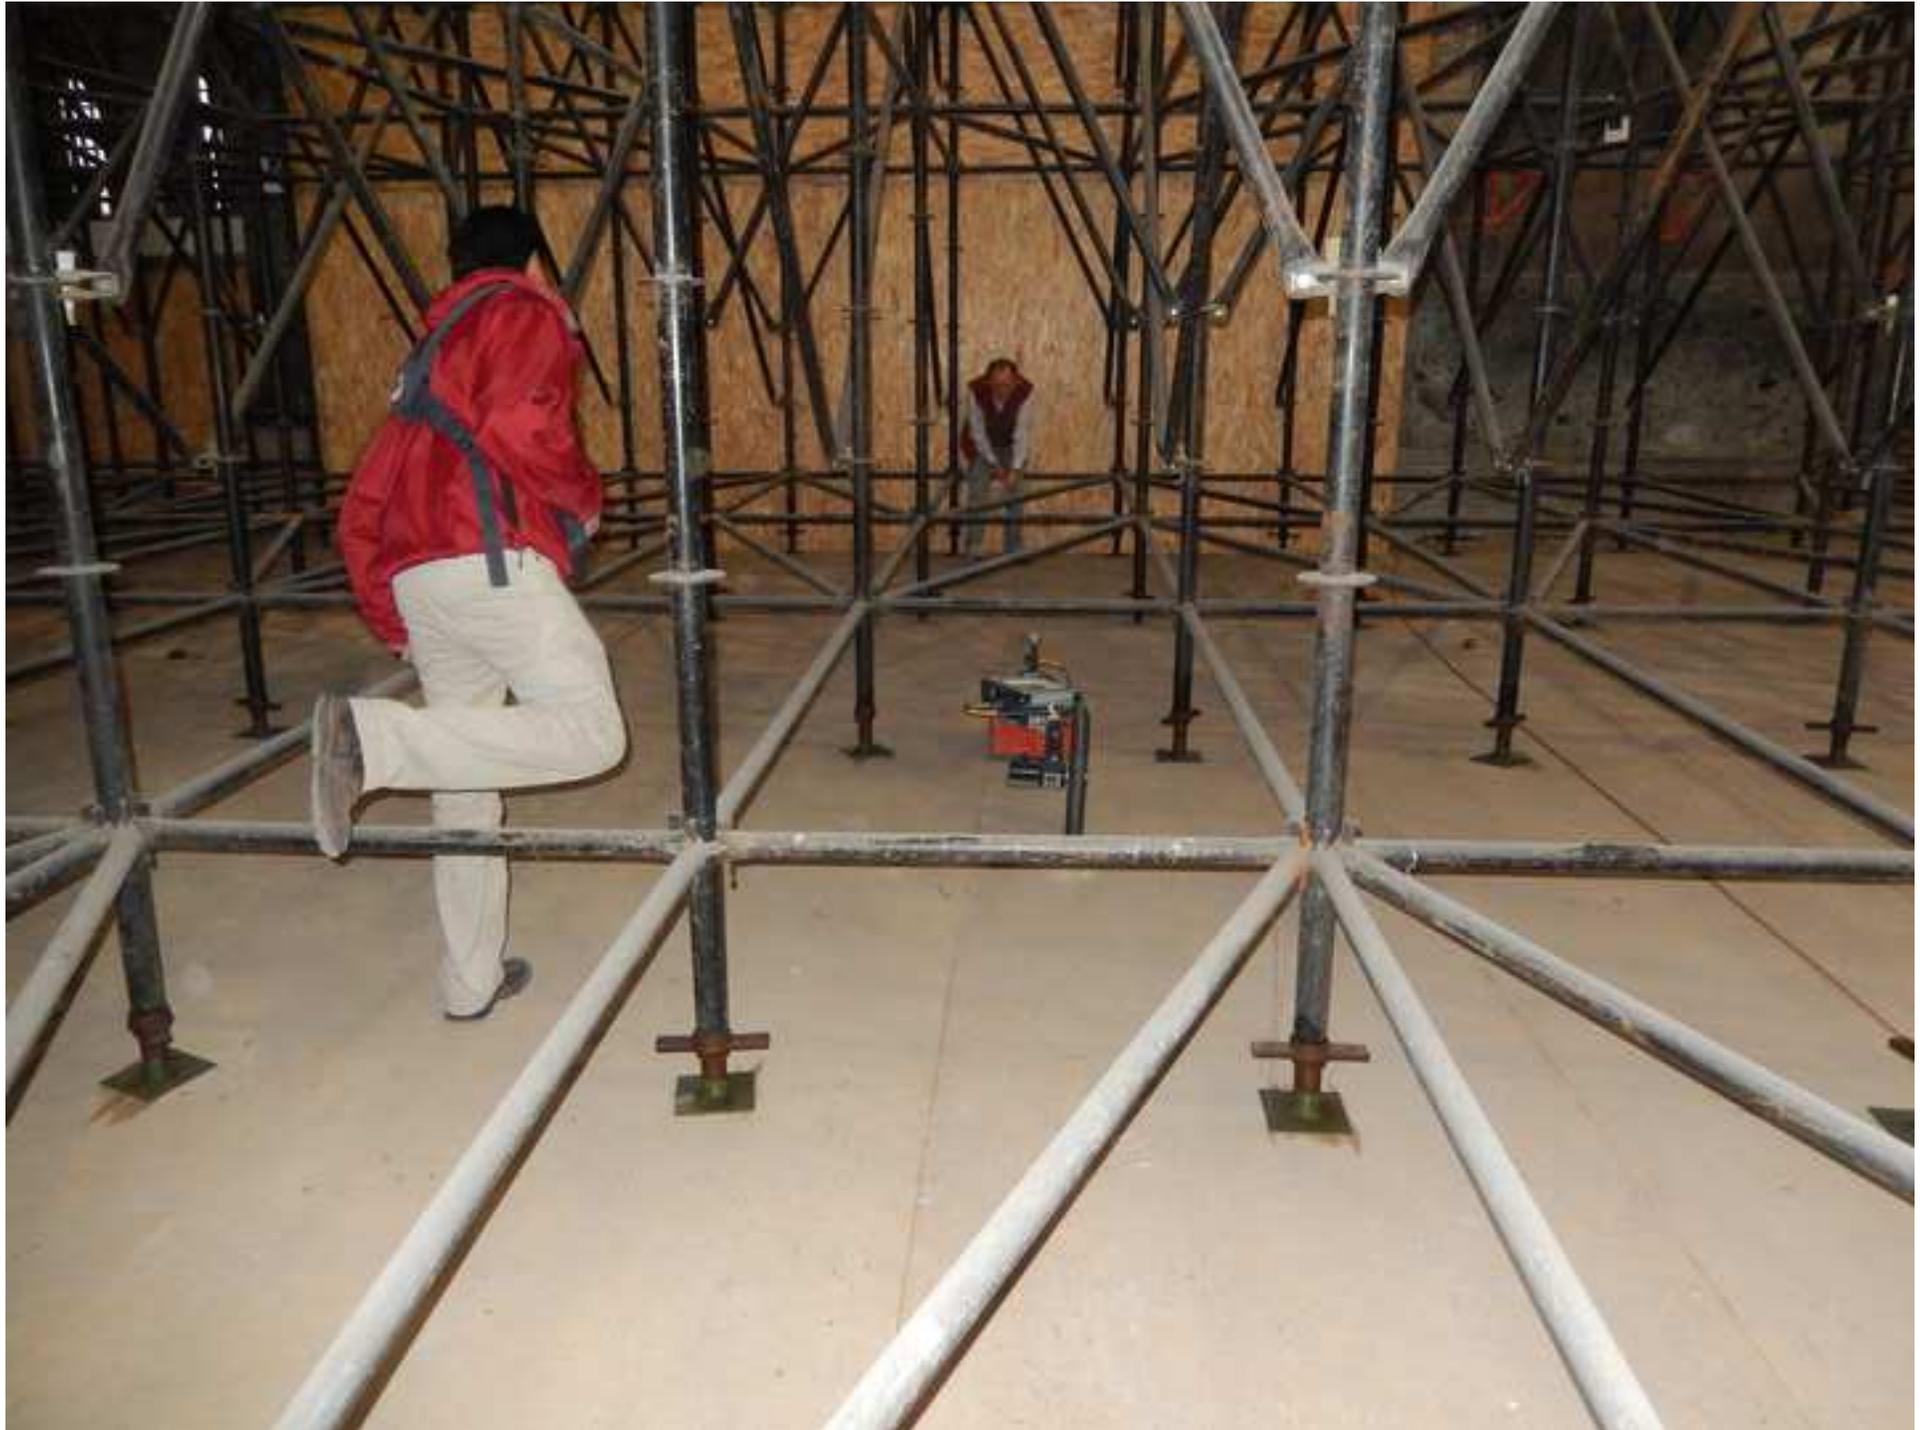
[Click here to download Figure: Figure 2.jpg](#)

Figure 2 The georadar equipment SIR3000 with 400 MHz antenna with survey wheel making parallel lines every 1 m, under the scaffolding

51 We undertook the work in the main nave on Monday because in these days the building is closed
52 to the public and there are no tourists inside, which allowed for a better development of the work.
53 As mentioned, the nave's northern half was covered by scaffolding set for the restoration works
54 (Fig. 2 and Fig.3). Due to the long term of these works we decided to carry out the survey
55 anyway. For this we draw lines S-N in the middle of the poles pulling the antenna and the
56 georadar control unit all the way through from one end to the other of the scaffolding (Fig. 2).
57
58
59
60
61
62
63
64
65

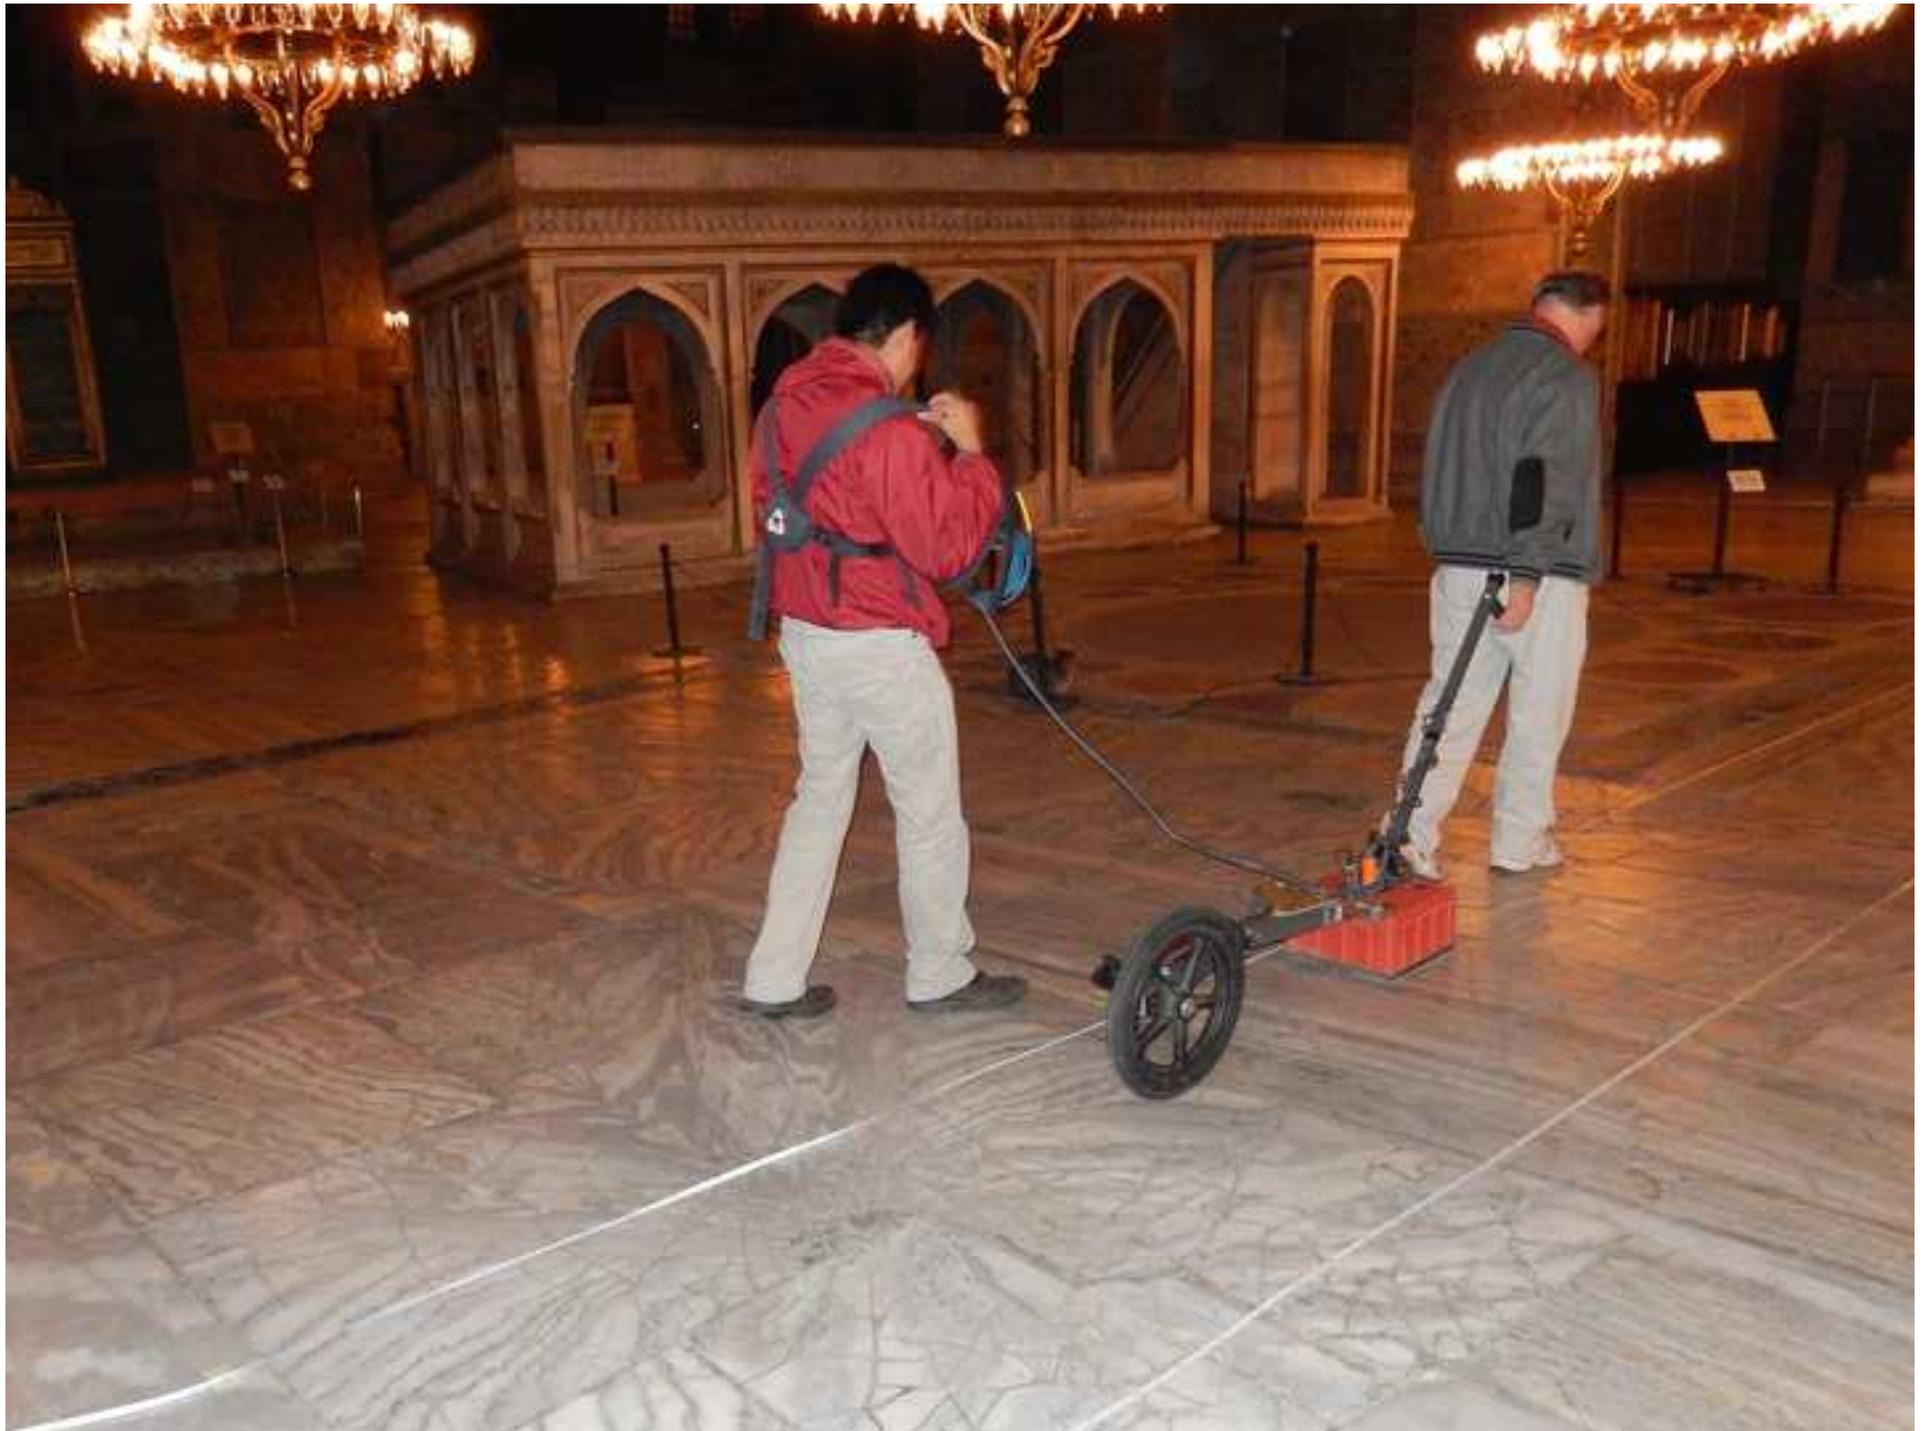
[Click here to download Figure: Figure 5.jpg](#)

Figure 5 Acquisition of georadar lines on the central nave floor close to the marble mosaic. To the back the Islamic muezzin's gallery can be seen

10 In Fig.10 it is possible to observe the previously mentioned walls, and slightly below, the
11 presence of a structure remains. In fact, in the individual radargram of line F68, between meter 4
12 to 7 there are reflections suggesting walls close to 2 m deep. In F72 there are some disordered
13 reflections in the first part (0-3 m). At meter 4 of the radargram, around 2 m deep, there is a
14 slight reflection that is more clearly displayed in lines F75 and F77, where it shows up as a
15 hyperbolic reflection. What is outstanding is that this structure is 1.5-2 m below the marble
16 mosaic that is located in the SE part of the central nave pavement (Fig. 5).
17

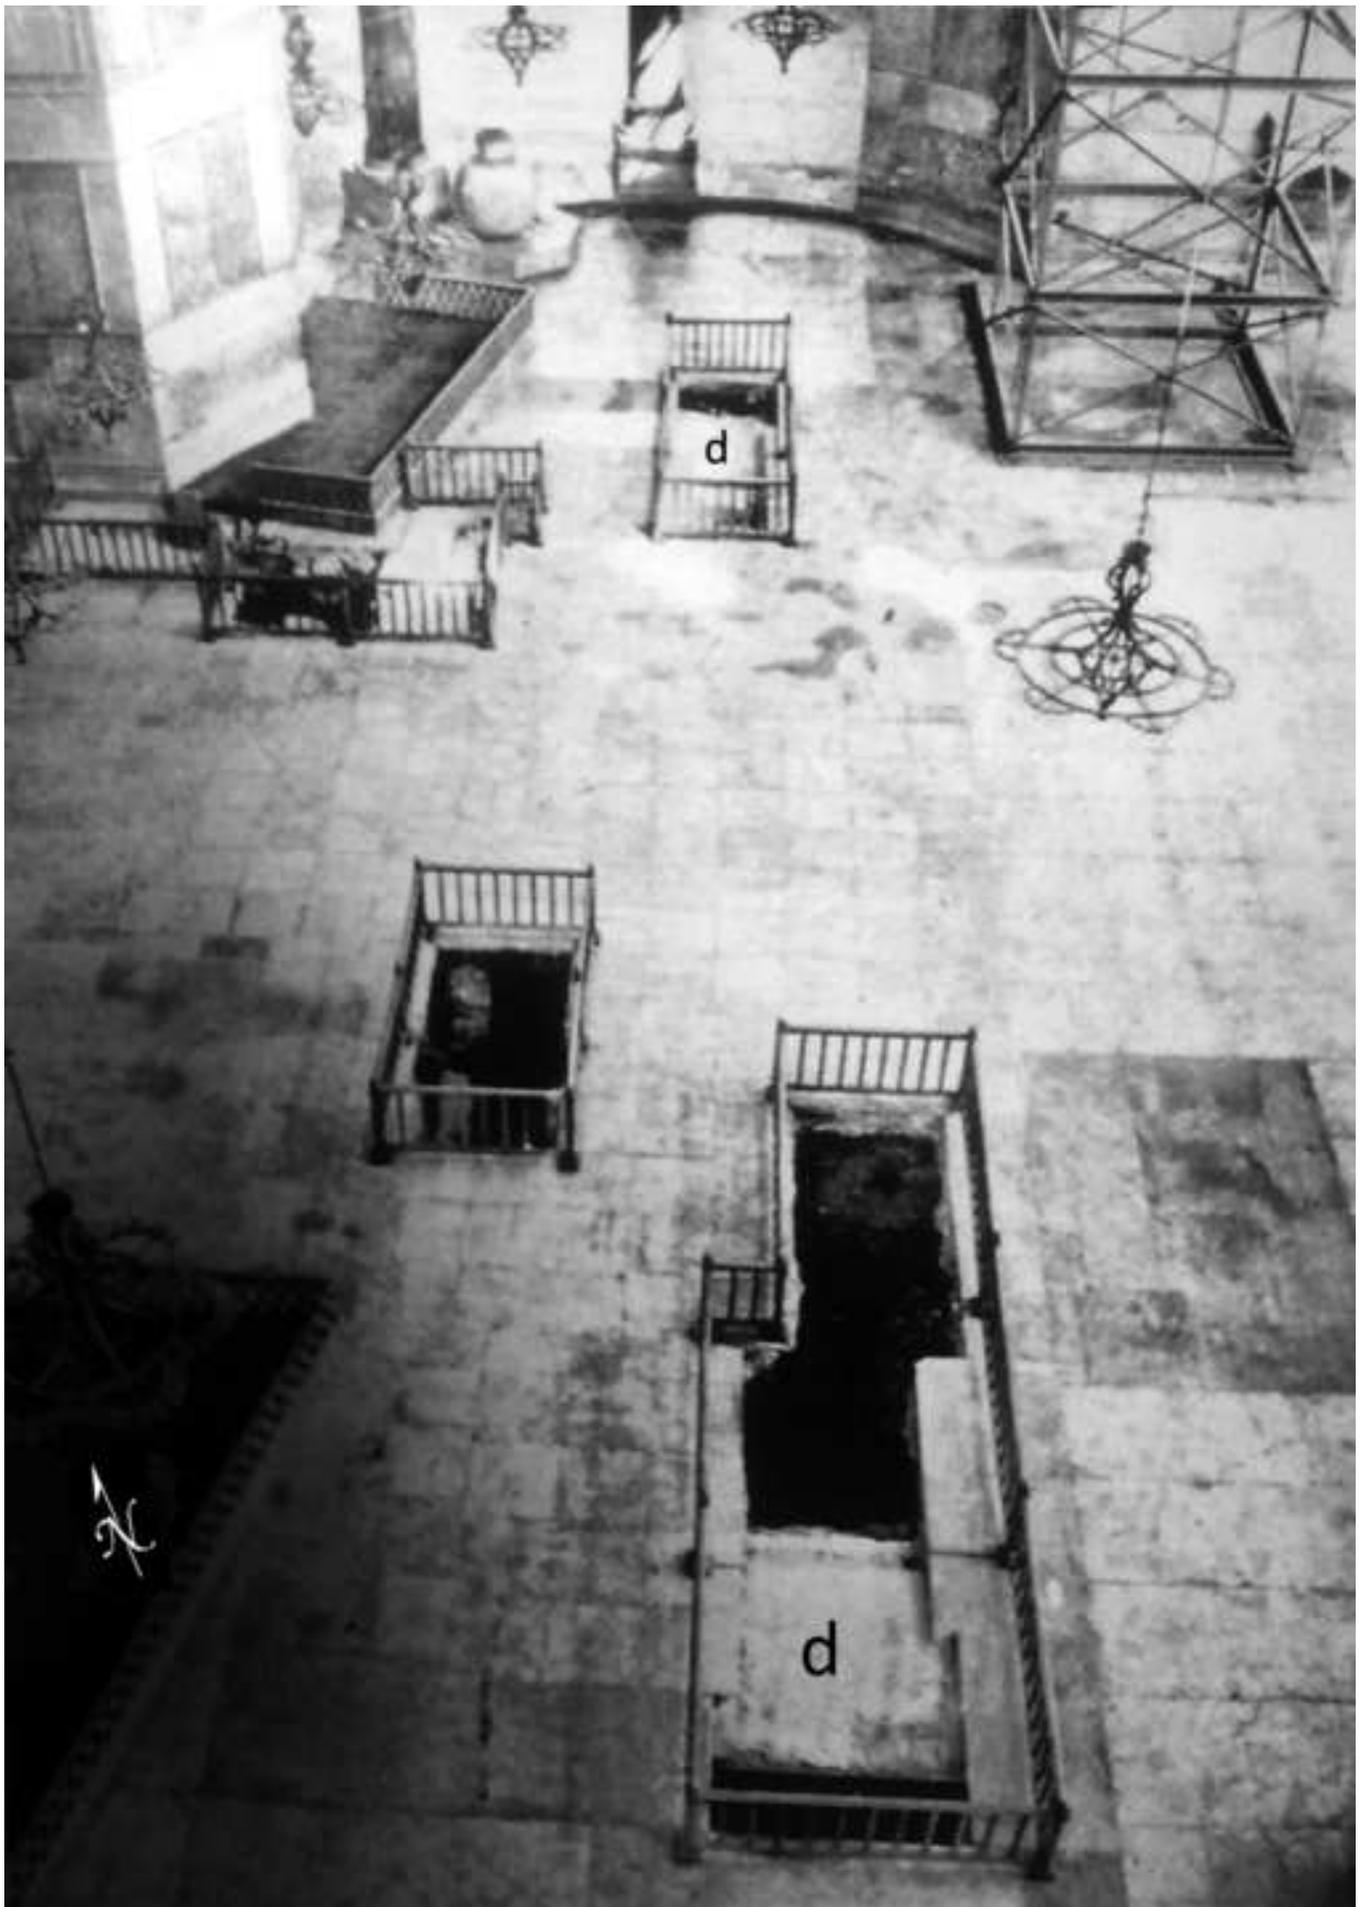
Figure
[Click here to download Figure: Figure 6.jpg](#)

Figure 6 Picture from the 50's showing some of the excavated areas. Marked with *d* letter are thick parallel walls under the marble surface (modified after Van Nice 1965)

In the 2 m high-resolution depth slice (Fig. 1) it is possible to observe the walls, which are showed in the photograph of the old excavations (Fig. 6).

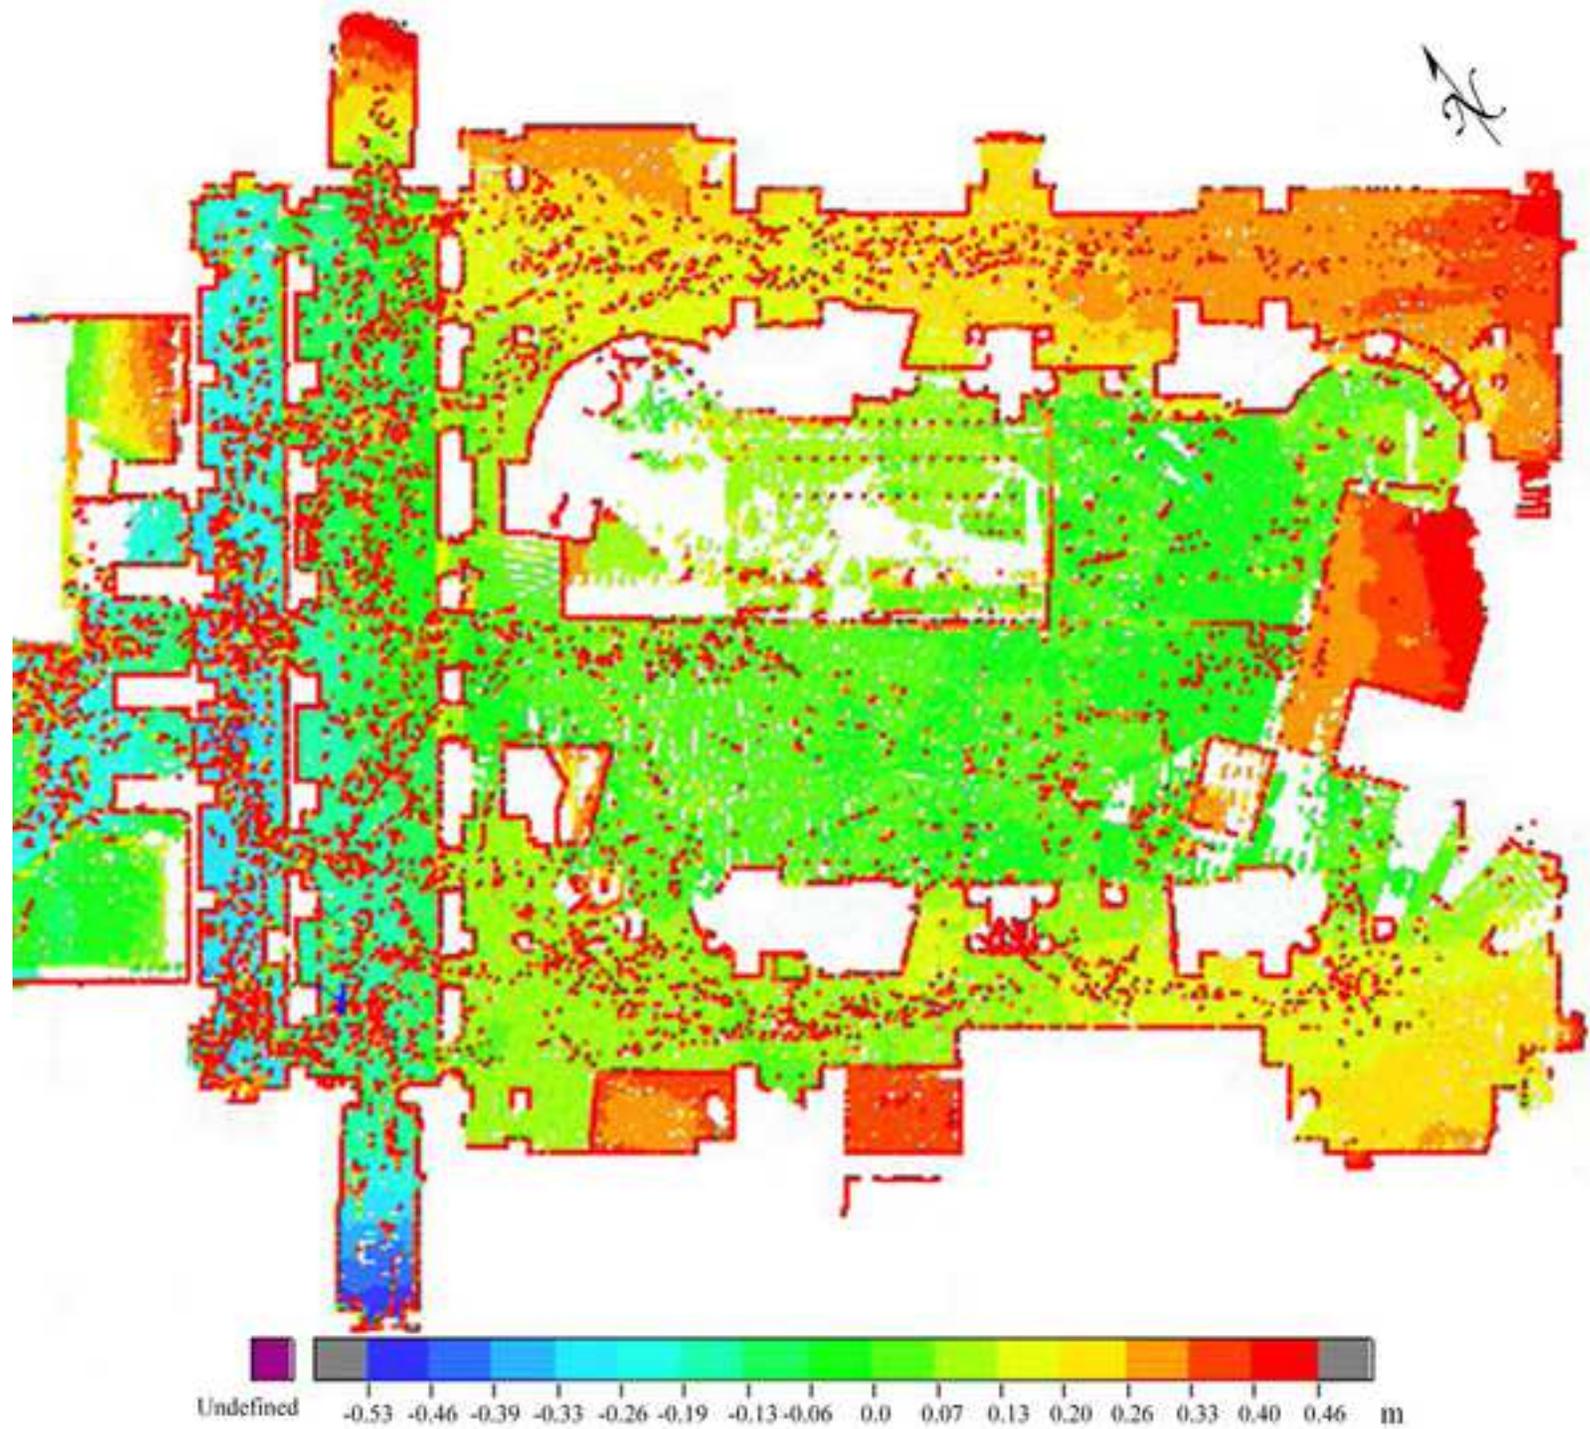
[Click here to download Figure: Figure 12.jpg](#)

Figure 12 Topographic map of the floor of the ground level of Hagia Sofia obtained by Leica Geosystems' Scan Station 2. In the central nave a flat area can be observed

Once the remains have been identified, in order to better understand if the remains located under the floor of Hagia Sofia’s central nave can be related to the deformation of the building, we compared the georadar data with the topographic map of the ground level floor surface, obtained processing the data of the 3D laser scan of the whole building (Fig. 12). Before commenting on the map, it is important to remember that the rectangular area in the apse of the central nave must not be taken into account, because it corresponds to the presence of a wooden structure placed in the area, which arises the level of the floor recorded by the 3D scan.

It is relevant to state that the topographic map of Hagia Sofia’s floor reveals that there are neither deformation, nor topographic changes in the central nave floor surface after more than 15 centuries of different uses of the building (Fig. 12). This reveals that the burial of the previous structures was made with great care using adequate materials and compacting them properly in such a way that, although there are remains of previous structures under the floor of Hagia Sofia, the central nave floor is stable, with almost no deformations.

On the contrary, in the lateral naves it is possible to observe slight changes in the level of the floor, indicating some sort of deformation of the ground surface. This is evident especially in the northeastern part of the building, where there is an augmentation of 40 cm in the height of the floor. This suggests that future studies should take into account the georadar survey of the lateral naves in order to understand if a relationship could be found between the presence of underlying structures, a different topography of the area and the deformation of the Hagia Sofia building.
