# Flood hazard map of La Trinidad (NW Nicaragua).

## Method and results

G. Furdada · L. E. Calderon · M. A. Marques

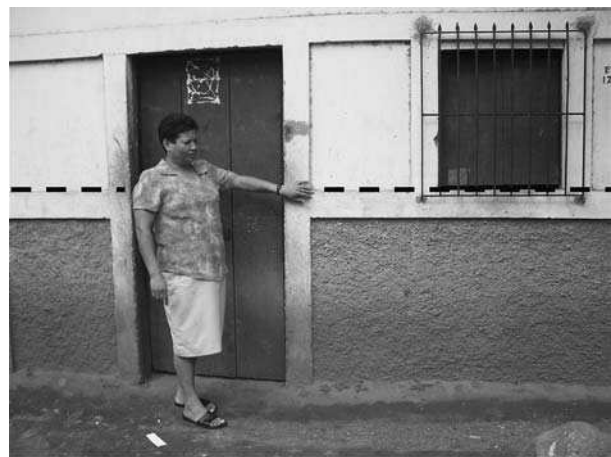
**Fig. 2** Woman showing the level reached by the water during the Mitch hurricane event (*black discontinuous line*). La Trinidad, 2004

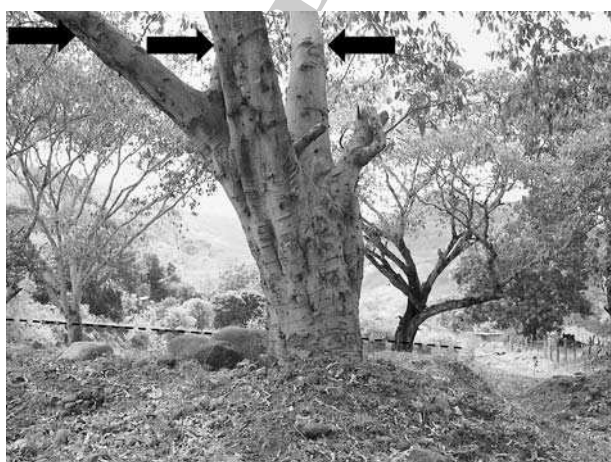
**Fig. 3** Impact marks on the trunk of a tree that grows on la Trinidad river bed. The impact marks were produced during the Mitch hurricane event. *Black arrows* indicate the higher impacts, produced by floating trunks. In the background, the level of the lower terrace is indicated with a *black discontinuous line*. La Trinidad, 2004

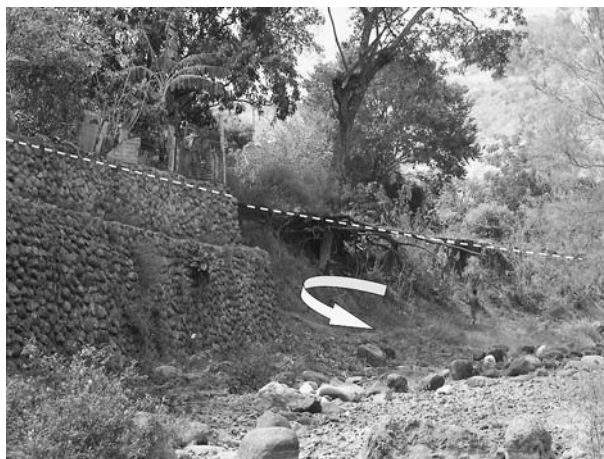
**Fig. 4** Image of the concave margin of a meander. Undermining is evident below the roots of the tree, where unconsolidated sediment is being eroded (*white arrow*). The dike, built after the Mitch hurricane event, is obviously too short and undermining is beginning to act behind it and therefore it will be ripped off. The lower terrace level is indicated with a *white discontinuous line*. La Trinidad, 2004

Reaches affected by undermining (Fig. 4) were mapped. It shows, on one hand, some preferential overflow points, and on the other hand, unstable reaches and tendency of meander evolution. Consequently, undermining indicates possible changes in flood prone areas.

Damage produced during the Mitch event (which reflect the flow energy) and post Mitch anthropogenic obstacles were also mapped and considered. Figures 4 and 5 show an example of a too short dike in a meander undermining zone and of an anthropogenic deposit into the river bed.

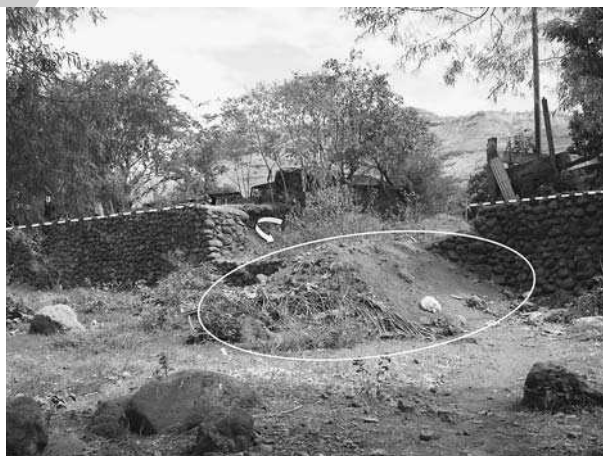
**Fig. 5** Image of a filling on La Trinidad river bed indicated with a *white circle*. The dike, built after the Mitch hurricane event, presents a discontinuity and erosion is beginning to act behind it (*white arrow*). The lower terrace level is indicated with a *white discontinuous line*. La Trinidad, 2004
