# Degradation of lingual orthodontics archwires

## The effect of corrosion and nickel release on their properties

Carlos Suárez Martínez

Faculty of Dentistry. University of Barcelona  
4<sup>th</sup> of December 2007

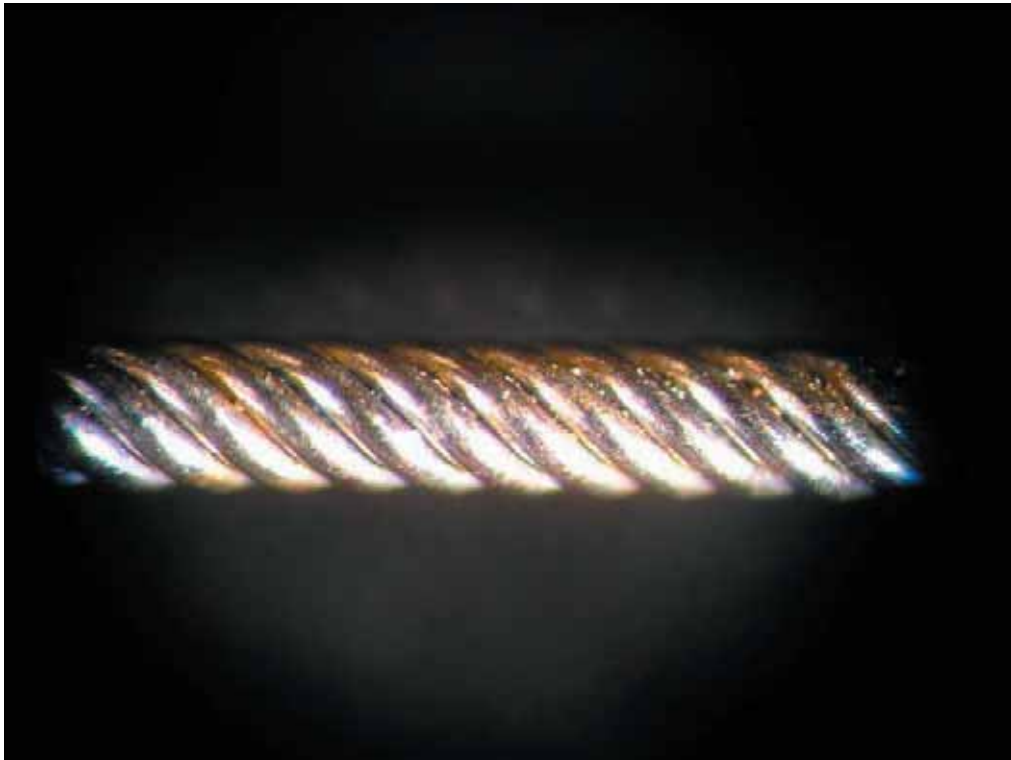
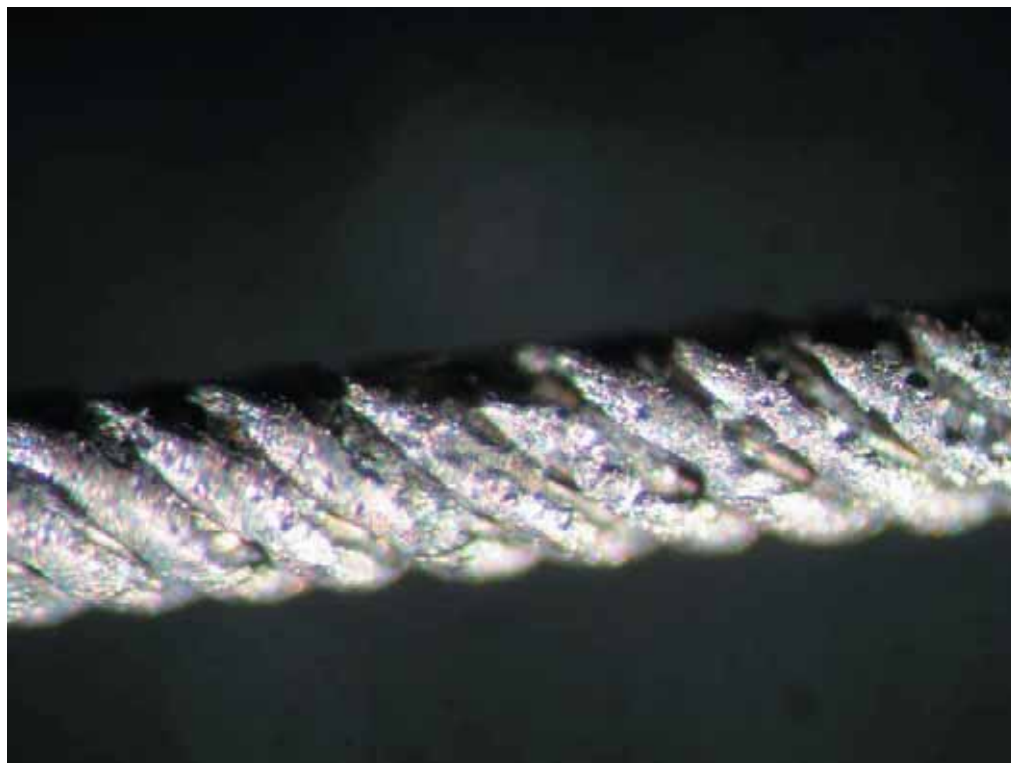
Photo 25

The Respond archwire (photo 25) showed a decreased shininess after polarization and an increased surface roughness as it can be seen from the photograph. Pitting corrosion can be seen all along the braided wires. A big island-like material loss that follows a particular pattern along one of the wires that form the Respond wire can also be observed. It is seen at the distal side of one of the braided wires where it contacts with the other one. It seems that the contact area is the most affected as seen from a macroscopic point of view.

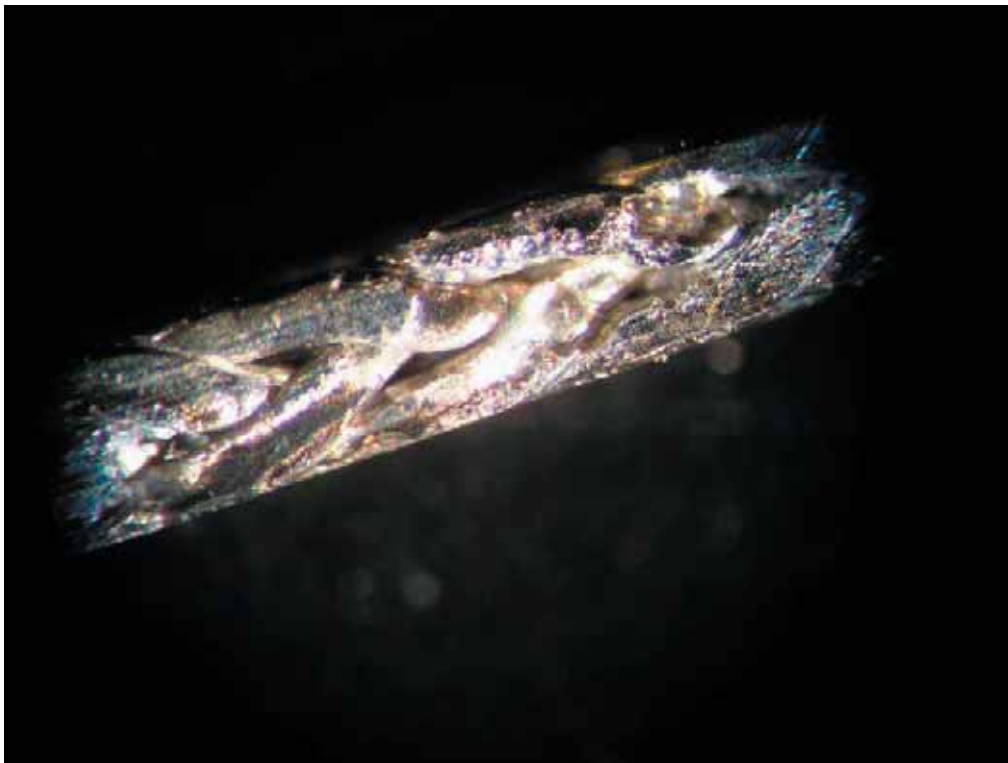
Photo 26

D-Rect (photo 26) does not seem to have lost its shining aspect after polarization. Pitting corrosion can be observed at flat surfaces and material loss in a severe way can be also seen. This loss is an impact-like shape with rounded edges. It seems that the most affected point coincides with the archwire edge of this rectangular braided wire.

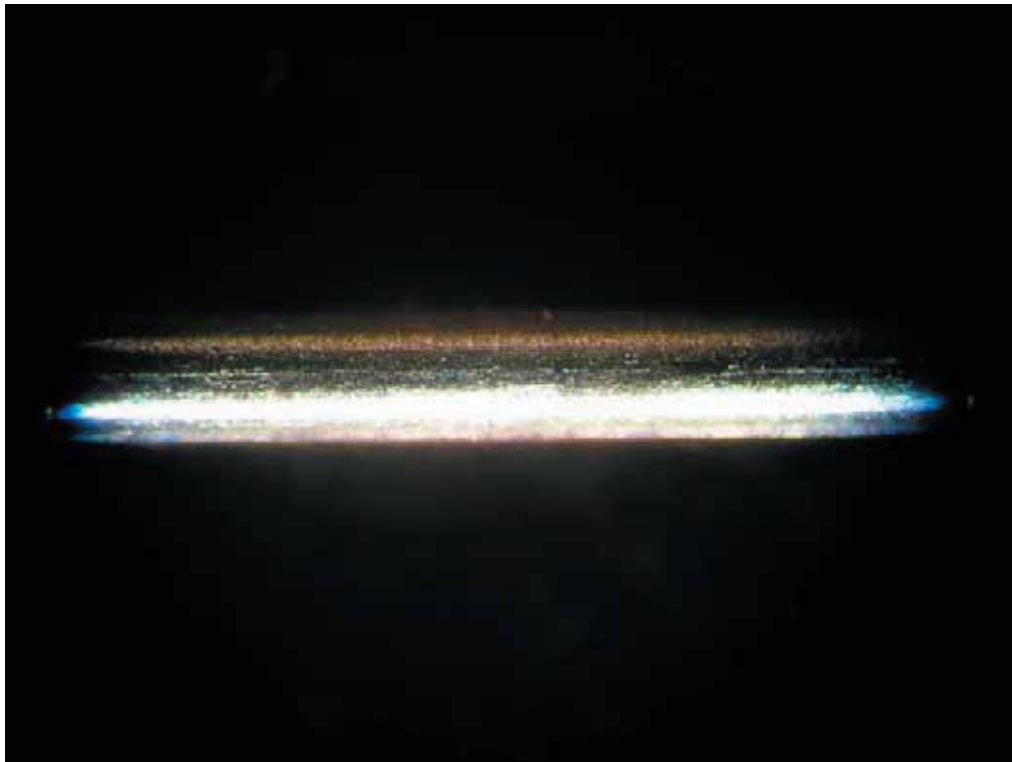
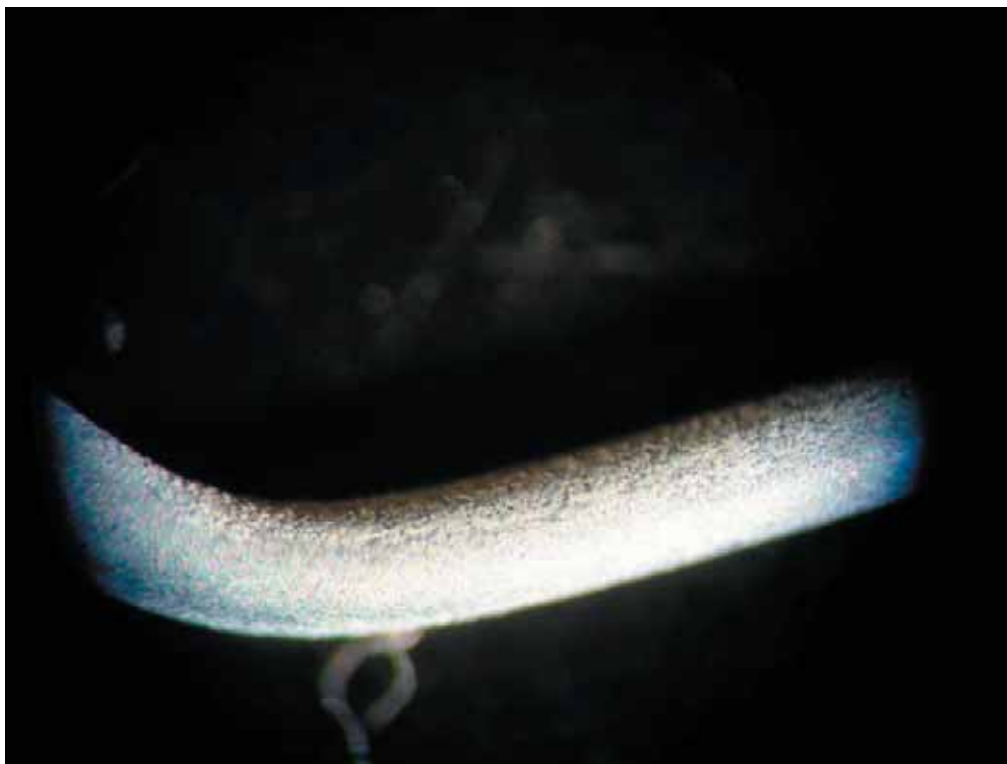
Photo 29

NiTi round wires (photo 29) conserved their general shape quite well after polarization. From the macroscopic point of view, there is a loss of shininess of the arch that becomes very grey and rough with a surface that recalls dry paint. The surface does not seem to be affected by pitting corrosion although it can be seen that a porous like loss of surface material has occurred.
