Belgeo

Water in the Anthropocene: social issues, policies and governance

River restoration in the Mediterranean area of Spain after flood events through three different case studies

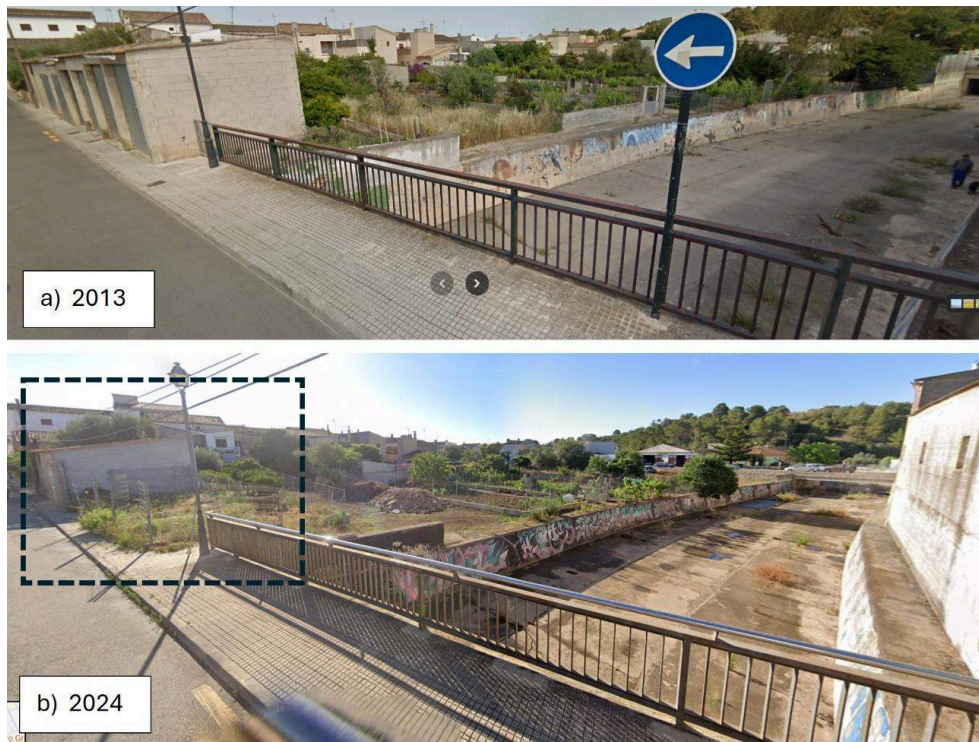
Figure 3. Image of one of the bridges crossing the channel. Both images are taken from Google Maps Street View.

a) 2013 and b) 2024. Note the disappearance of the garages and the traffic sign placed in image a) respect the same location in image b).

- 13 According to Lorenzo-Lacruz *et al.*, (2019), bridges acted as a water retention obstacle, favouring water overflowing and running through adjacent streets. In addition, the estimated flow velocity due to the presence of a concrete channel dramatically increased hazards, given that it could reach values as high as 7 m s^{-1} at some points (Lorenzo-Lacruz *et al.*, 2019). The channelization and the concrete transformation of the torrent section took place after a flood in 1989, in which a rainfall event of 156 mm in 2 h affected several areas of the village (Lorenzo-Lacruz *et al.*, 2019). The maximum capacity of the river section is $161 \text{ m}^3\text{s}^{-1}$, which is a value much smaller than the $307 \text{ m}^3\text{s}^{-1}$ simulation obtained by the authors (Lorenzo-Lacruz *et al.*, 2019), and the $442 \text{ m}^3\text{s}^{-1}$ measured in the hydrometric station of the torrent during the event (Estrany *et al.*, 2020).

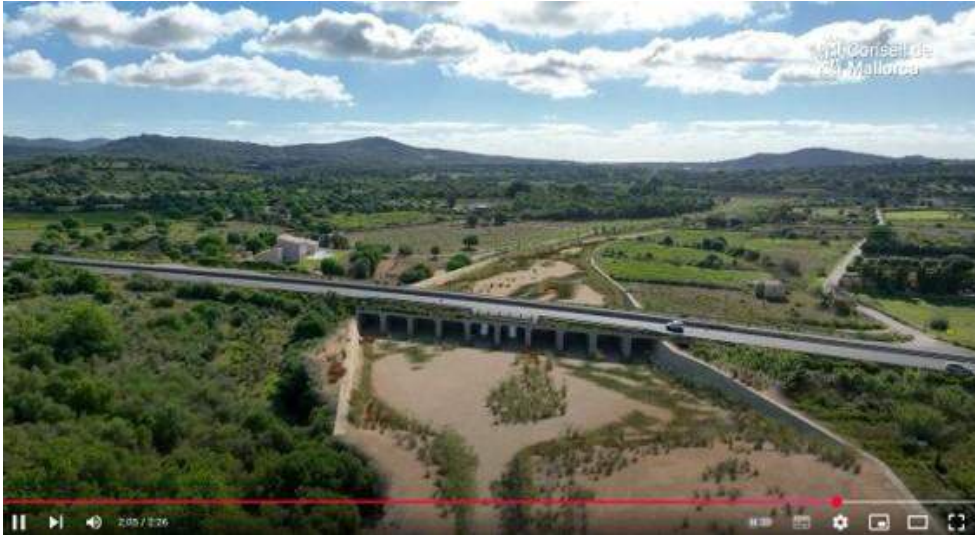
Figure 4. A snapshot of the enlargement of the river section project downstream of Sant Llorenç.

This is the only “improvement” project presented after the occurrence of the severe event (Consell de Mallorca, 2024).

- 15 From the studies cited it could be derived that the channelization was insufficient to hold a flood of this magnitude and that the bridges and channel corners acted as water stoppers for flow and debris (Lorenzo-Lacruz *et al.*, 2019). The “improvement” proposal of the river section was to increase its width when the channel crossed the highway located downstream from the village, to “facilitate or enhance the drainage”. Fig. 4 shows a snapshot of a video promotion of the “enhancement” of the river channel

when crossing the highway. However, 7 years after the event, the project presented has not been built and no further actions within the river channel when crossing the town have been considered.

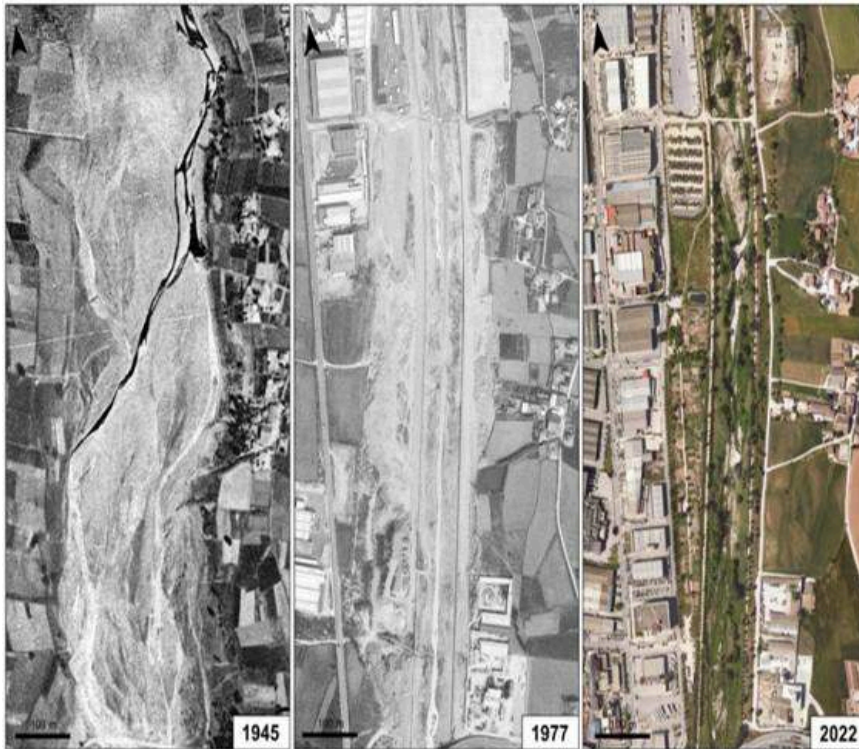
Figure 8. Evolution of the river channel at Granollers from 1945 (left) to 2022 (right). The river channel has been reduced from 300 m wide in 1945 to 80 m in 2022.

- 24 Of the case studies presented, the restoration of processes in the Congost River in Granollers is probably the best example of a combination of river re-naturalization with a recuperation of proper fluvial hydro-geomorphological river processes. Granollers is a city of 60,000 inhabitants, located 30 km north from Barcelona and belonging to its metropolitan area (Fig. 1). The Congost River flows through the city and it was channelized and disconnected from its floodplain due to the severe floods in the metropolitan area in 1962, which resulted in more than 800 casualties and persons disappearing (La Vanguardia, 1962). During 1970’s the river was channelized to prevent flooding and gradually the floodplain became occupied by industrial polygons and buildings due to the city growth and expansion (Fig. 8).

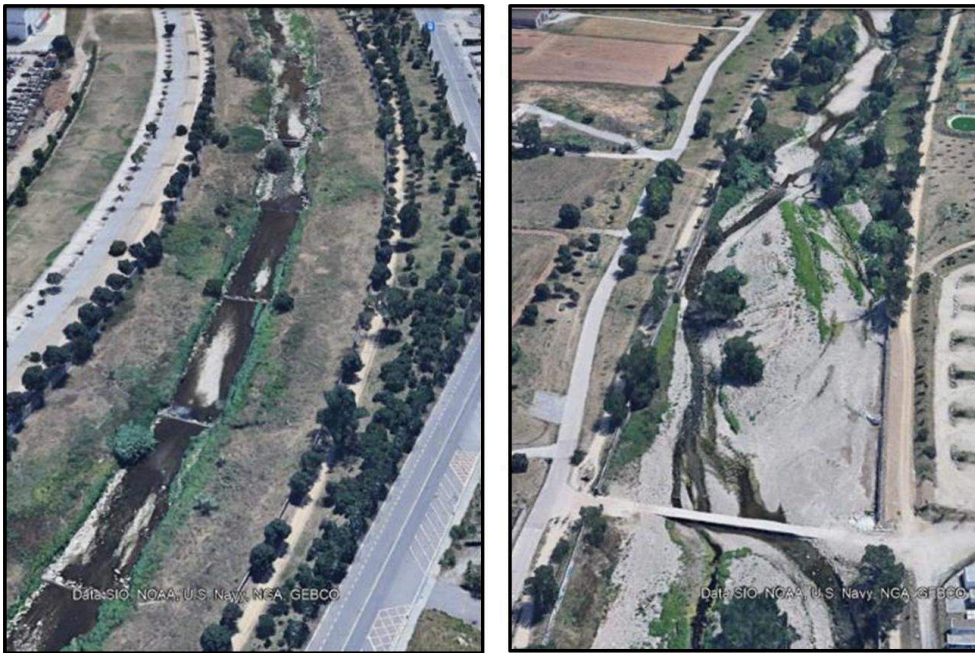
Figure 9: a) Example of the unrestored and b) restored Congost River section in Granollers.

- 25 The municipality of Granollers started to remove concrete structures in the river stretch downstream from the main urban nuclei during the period 2007-2010 to increase the biodiversity and transform the artificial-concrete channel to a “better shaped river”. The removal of such structures allowed the river to recover lateral mobility as well as longitudinal connectivity. After just over a decade, the river has recovered its own natural processes by eroding the artificial banks and redistributing the sediment along the river section (Fig. 9). The river started to create proper river morphology according to the slope, the sediment available and its calibre, and the flood regime. A trend in the recovery of the initial braided channel morphology, still visible in 1945 (see Fig. 8a), is detected in Fig. 9b. The ecological status of this river stretch, in comparison to the river section that was not re-naturalized, has improved (Farguell *et al.*, 2024a).
