ARE PATINAS OF MEDITERRANEAN MONUMENTS REALLY RELATED TO THE ROCK SUBSTRATE?

SUMMARY

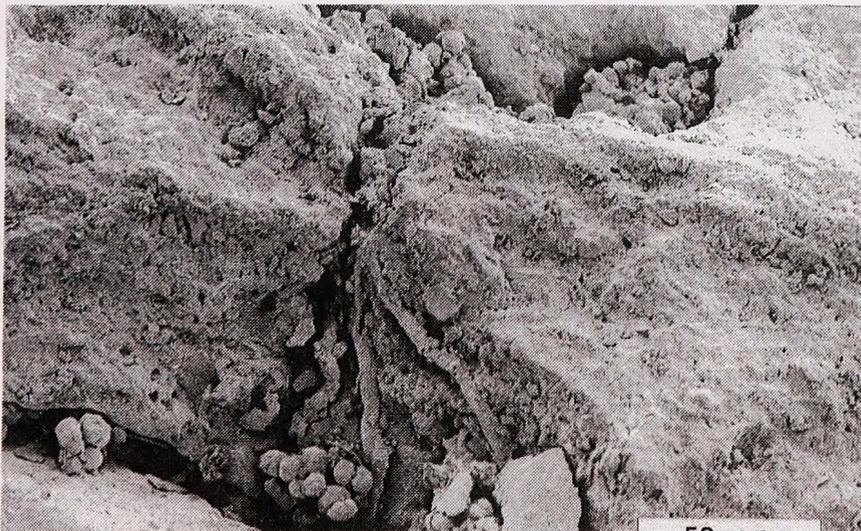
Fig. 10: Orange micritic layer developed on a siliceous sandstone. The patina itself is colonized by black yeast-like fungal colonies (upper part of the photo) which develop hyphae penetrating inside the patina and leading to its decay. The sample corresponds to the Monastery of Sant Cugat del Vallès.

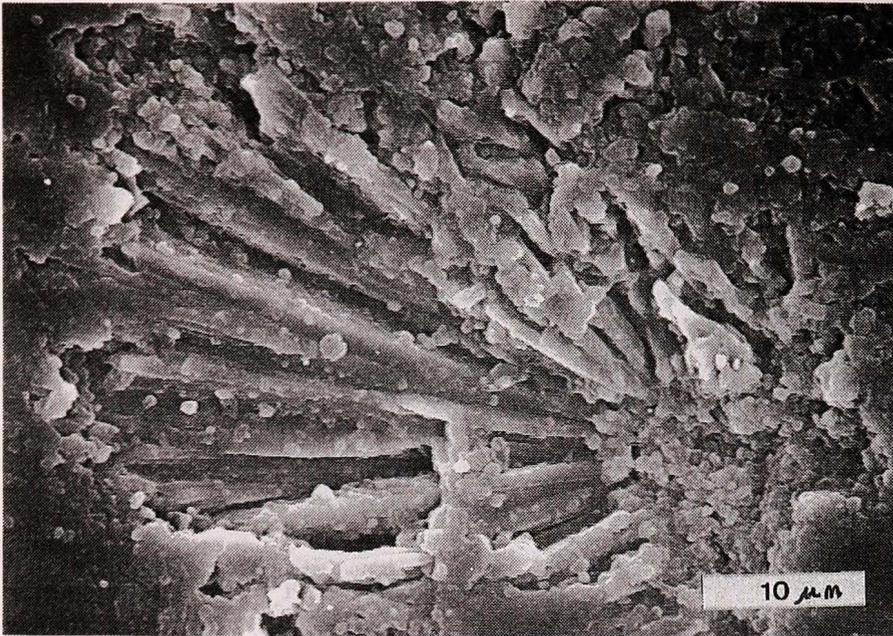
Fig. 11: SEM image of a spherulitic arrangement of calcite crystals around a central micritic nucleus which is rich in P. It corresponds to a microstromatolitic layer developed on granite. Cathedral of Seu d'Urgell.

Inside the stromatolithic structure there exist several spherulitic arrangements of crystals with a P-rich micrite in the centre (Figure 11). The only possible origin for this kind of crystal arrangement is biological. Moreover, in some cases of recent crusts in monuments the biological body has been observed as a remain in the centre of the spherulite. Several geological authors describe the same phenomena in calcareous and phosphatic stromatolites.
