Manuscript number	ENGEO_2018_304
Title	Assessing preferential seepage and monitoring mortar injection through an earthen dam settled over a gypsiferous substrate using combined geophysical methods
Article type	Research Paper

- 1 Assessing preferential seepage and monitoring mortar injection through an earthen
- 2 dam settled over a gypsiferous substrate using combined geophysical methods
- 3

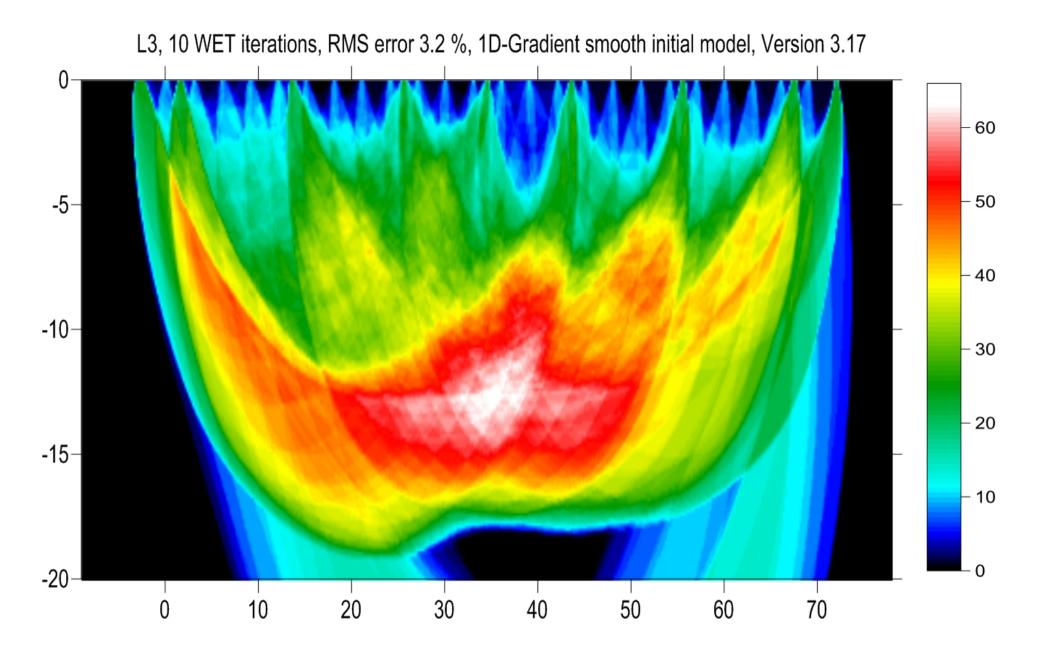
523 Figure 9. Inverted seismic refraction tomography pseudo-sections start off the distance 200 m 524 of the levee because before this distance the noise produced by the hydropower plant was high.

236 The seismic record data was processed and inverted. The 1D initial model still shows a good 237 initial travel time fit between measured and picked times (Figure 8.a). In all the profiles, the data 238 that were observed and calculated have a difference in RMS error of less than 5%. Seismic travel 239 time tomography requires optimisation of both the distribution of seismic velocities and the 240 paths along which the wave has travelled, or ray paths. Figure 8.b displays the distribution of ray 241 paths corresponding to the optimum solution. The obvious use of this map is to establish the 242 relative sampling of the subsurface. Results in areas with low ray coverage would have lower confidence than areas of high ray coverage (Hickeyet al., 2010). Rayfract™ uses the ray coverage 243 244 map to establish spatial bounds on the velocity tomogram. For this survey, the ray coverage is 245 highest in the middle of the survey and lower near the surface and edges, which is typical for a 246 material with a fairly uniform vertical velocity gradient. The inverted velocities from the 247 refraction analysis showed multiple velocity intervals, from the surface to the base. This shows 248 that there are several strata within the overburden, with variable thicknesses and velocities. In 249 general, the velocity increases with depth, from about 300 m/s near the surface to more than 250 2000 m/s (Fig. 9). The corresponding velocities indicate a three-layered structure. The upper 251 layer with low velocity values of under 1000 m/s was recorded in all profiles. Although the 252 average thickness of this layer is about 4 m (profiles 1 and 3), some stations recorded thicknesses 253 greater than 5 m (the stations at the distances 290, 370 and 400 m), while other stations 254 registered thicknesses of less than 2 m (at distances 230, 275, 330 and 455). The intermediate 255 seismic layer has values between 1000 and 1800 m/s, and reaches an average depth of between 256 12 and 14 m in all profiles except P4 and P6, where it goes deeper. Below these two seismic 257 layers lie a layer with a significantly higher velocity (above 2000 m/s). This layer appears at a 258 depth of less than 10 m in profile 7.

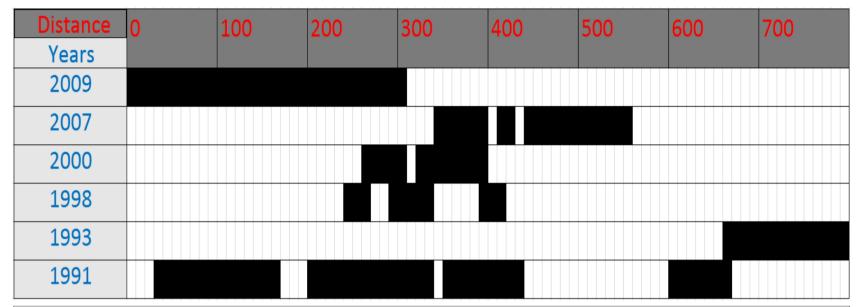
Figure 10. Areas of concrete injections along the levee and the relative movement of the leveefor different years.

The comparison between the results obtained by the different geophysical methods shows that the areas where the electrical resistivity values (ERT) are lower than the expected values coincide with the areas of high electrical conductivity (EM31) and accord with areas of low seismic velocities. These zones are located at the distances 80, 400 m and coincide with seepage areas. Whereas , the areas with high electrical resistivity (ERT) coincides with low electrical conductivities (EM31) and with high seismic velocities. These anomalies are a consequence of areas of mortar injections (225,300, 640 m)
