Treball Final de Grau

**Study of fire safety measures for an existing sports facility in
accordance with current building regulations.**

Silvia Garrido Salmeron

(January 2025)

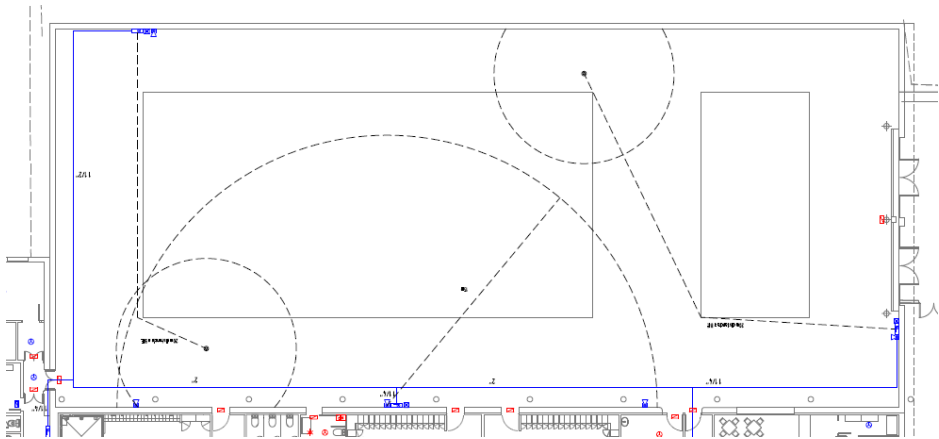
Figure 5. Details of plan 3

For the extinguishers, it has been drawn a circle with a 15-meter radius centered on each extinguisher and repeated this process for all existing extinguishers. The installation is considered covered if all the circles touch or overlap. In areas where this condition was not met, the location for a new extinguisher has been marked. Figure 5 provides an example of this procedure, where the larger semi-circle represents the coverage area of the extinguisher.

For the BIEs, it has been followed a similar approach but measured a distance of 20 meters from the BIE (represented as an initial 20-meter radius circle, not drawn), which corresponds to the hose length, followed by an additional 5-meter circle from that point, representing the nozzle reach of the BIE. The total area covered by a BIE is the combined area of these circles. This

process to all existing BIEs has been applied, and in areas not covered, it has been proposed to install a new BIE. Figure 5 shows an example of this process.

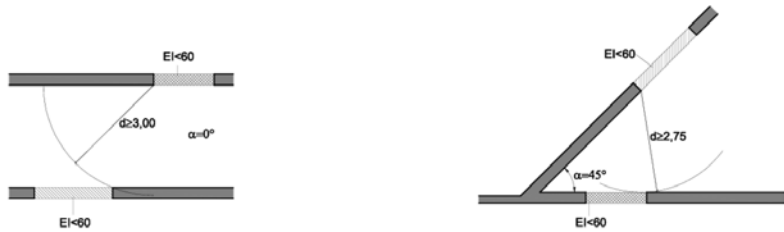
Figure 8: Required Separation Distance Between Two Openings of Two Fire Sectors.

α	0° ⁽¹⁾	45°	60°	90°	135°	180°
d (m)	3,00	2,75	2,50	2,00	1,25	0,50

The sports center has an irregular shape and is not adjacent to any neighboring building; therefore, it **complies** with this section on exterior propagation concerning neighboring buildings.
