International Biodeterioration & Biodegradation

Microscopic, chemical, and molecular-biological investigation of the decayed medieval stained window glasses of two Catalan churches

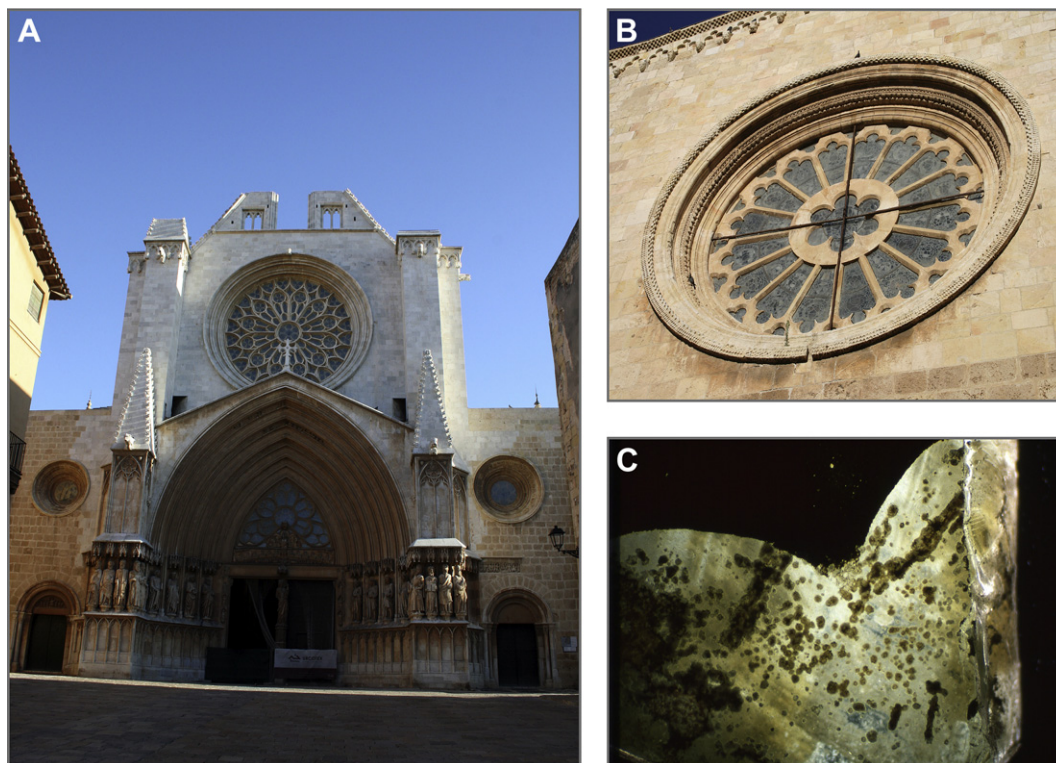
Fig. 1. Cathedral of Tarragona. 1A: Detail of the façade. 1B: Detail of the rosette glasses of the transept from the Cathedral of Tarragona. 1C: Detail of a glass piece with deterioration signs looking like *Cladosporium* attack.

The rosette glasses of the transept from the Cathedral of Tarragona (Fig. 1) date back to the beginning of the 14th century. They show evidence of damage and repair after the War of Independence (1808–1812) as well. All stained glass windows show original black-fired draws (grisailles), but our present study is only concerned with the composition and corrosion of the main pieces of glass.

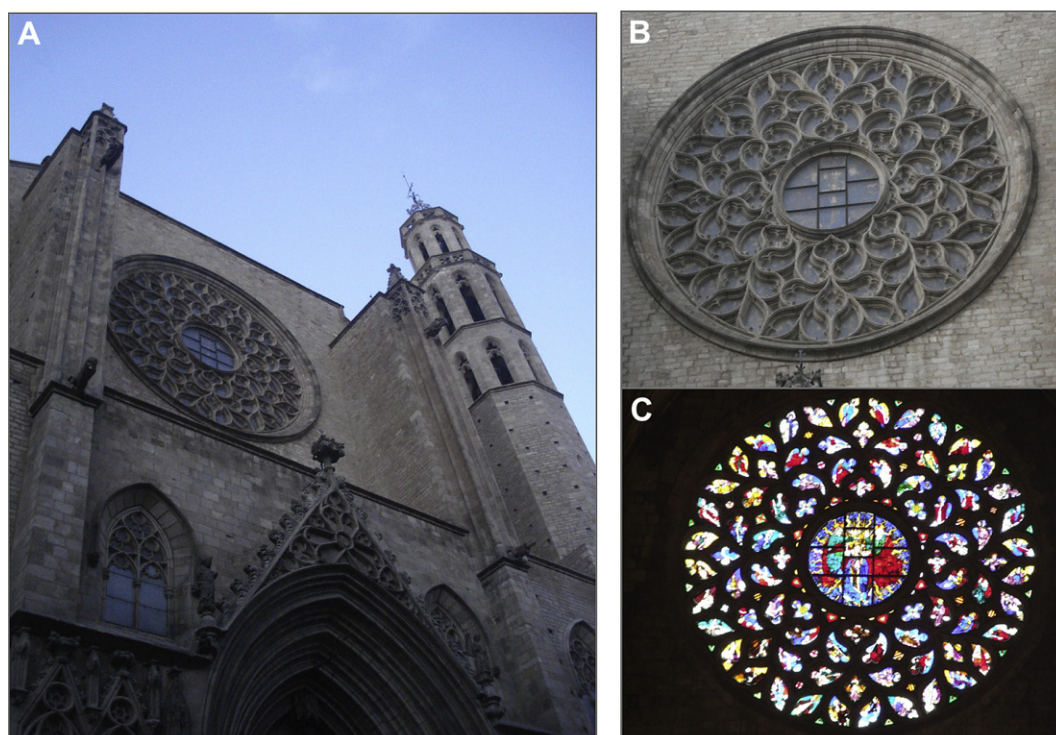
Fig. 2. Church of Santa Maria del Mar, Barcelona. 2A: Detail of the façade. 2B: Detail of the outer rosette glasses. 2C: Detail of the inner rosette glasses.

The church of Santa Maria del Mar in Barcelona (Fig. 2) is a medieval building erected in the 14th century but the large rosette on the main façade was destroyed by the 1428 Pyrenees earthquake and the stained glass window was rebuilt during the 15th century. Over the centuries, damage and repairs have led to a mixture of old glass panels and new ones, with the most important modifications probably dating from the Spanish War of Independence and the Spanish Civil War (1936–1939) (Ainaud de Lasarte et al., 1985).

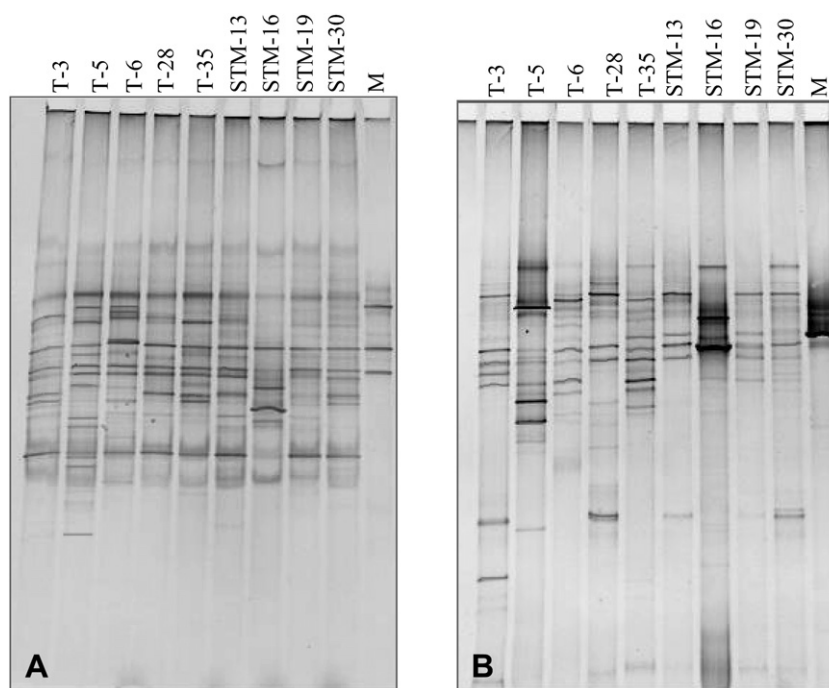
Fig. 4. DGGE fingerprints of DNA fragments encoding bacterial 16S rDNA, using a linear gradient of denaturants of 25–60% (A) and the fungal ITS1 region, using a linear gradient of denaturants of 20–50% (B) derived from original stained glass window samples of the Cathedral of Tarragona and the church of Santa Maria del Mar. Numbers of lanes represent the different glass samples. T: Tarragona; STM: Santa Maria del Mar. M: marker: a mixture of *Bacillus pumilus*, *Pseudomonas stutzeri*, and *Myxococcus xanthus* (A), *Cladosporium* sp. (B).

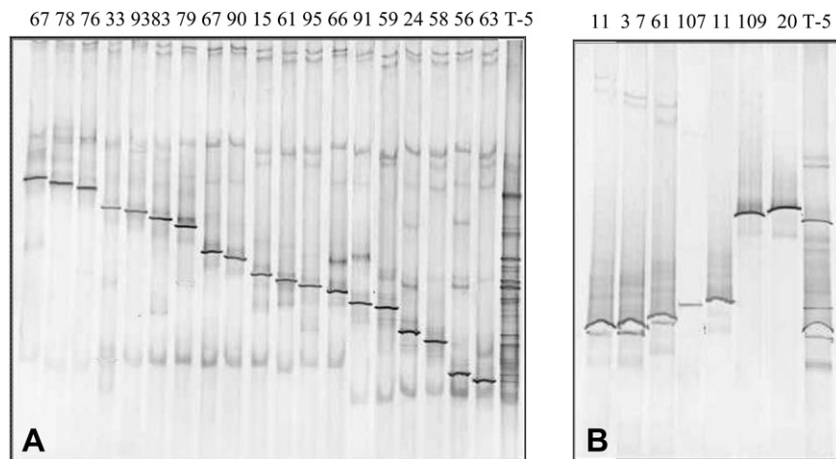
Fig. 5. DGGE fingerprints of DNA fragments encoding the bacterial 16S rDNA, using a linear gradient of denaturants of 25–55% (A) and the fungal ITS1 region, using a linear gradient of denaturants of 20–40% (B) derived from sample T-5 of the Cathedral of Tarragona, as well as the profiles of sequenced clones. Nomenclature indicates the numbers of clones, as indicated in Tables 3 and 4.

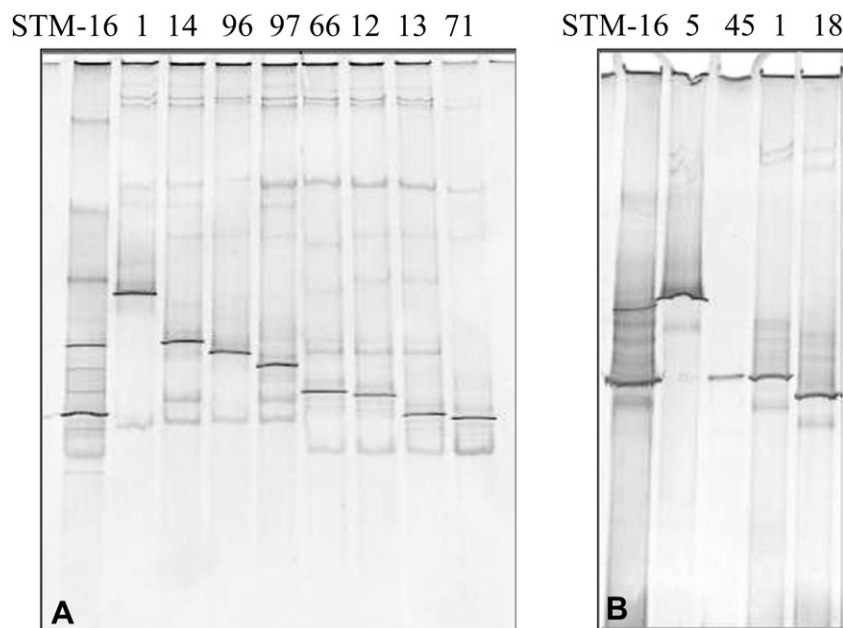
Fig. 6. DGGE fingerprints of DNA fragments encoding the bacterial 16S rDNA, using a linear gradient of denaturants of 25–55% (A) and the fungal ITS1 region, using a linear gradient of denaturants of 20–40% (B) derived from sample STM-16 of the church of Santa Maria del Mar, as well as the profiles of sequenced clones. Nomenclature indicates the numbers of clones as indicated in Tables 3 and 4.
