Long-term Operation of the Multi-Wire-Proportional-**Chambers of the LHCb Muon System**

ABSTRACT: The muon detector of LHCb, which comprises 1368 multi-wire-proportional-chambers (MWPC) for a total area of 435 m², is the largest instrument of its kind exposed to such a high-radiation environment. In nine years of operation, from 2010 until 2018, we did not observe appreciable signs of ageing of the detector in terms of reduced performance. However, during such a long period, many chamber gas gaps suffered from HV trips. Most of the trips were due to Malter-like effects, characterised by the appearance of local self-sustained high currents, presumably originating from impurities induced during chamber production. Very effective, though long, recovery procedures were implemented with a HV training of the gaps in situ while taking data. The training allowed most of the affected chambers to be returned to their full functionality and the muon detector efficiency to be kept close to 100%. The possibility of making the recovery faster and even more effective by adding a small percentage of oxygen in the gas mixture has been studied and successfully tested.

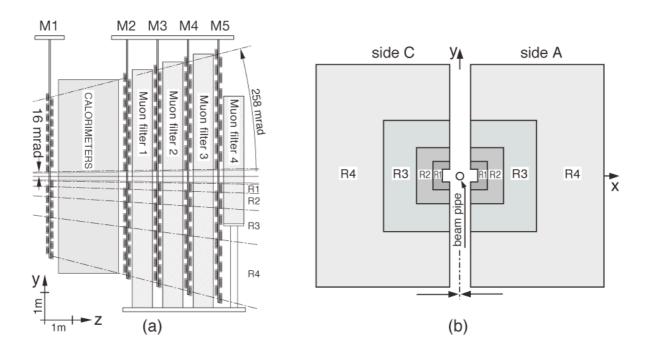
Figure 1. (a) Side view of the LHCb muon detector. (b) Station layout with the four regions R1-R4 indicated.

The muon detector of the LHCb experiment [1, 2] consists of five stations M1–M5, placed along the beam axis. Station M1 is located in front of the calorimeters and is used to improve the measurement of the muon transverse momentum for the first level trigger. Stations M2–M5 are placed behind the hadronic calorimeter and are interleaved with iron absorbers to select penetrating muons. As shown in figure 1, each station is divided into four regions R1–R4. The area of these four regions scales, from R1 to R4, with the ratios 1:4:16:64, while the irradiation per unit area decreases. In total, the muon detector is equipped with 20 types of chambers, varying mainly in size. MWPCs are used everywhere, with the exception of region R1 of station M1, where triple-GEMs [6] were adopted due to the higher irradiation.

The whole detector comprises 1380 chambers (1368 MWPCs and 12 GEMs), for a total active area of 435m². Since the requirements on spatial resolution and rate capability, as well as constructional constraints, vary a lot in different stations and regions, different chamber segmentations and different readout techniques were employed. In the outer regions (R4) there are large wire pads while in the inner regions there are small cathode pads or even smaller logical pads obtained by crossing cathode pads with narrow wire strips [1]. The number of MWPCs installed in each region of the detector, their relevant characteristics and the charge integrated so far per unit length of wire, are listed in table 1.

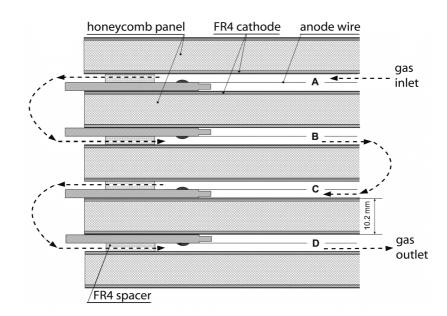
Figure 2. Cross section of a MWPC with four gaps indicated by A, B, C and D. The direction of the gas flow is shown by the dashed lines. On the detector, a maximum of 8 MWPCs are connected in series on the same gas line, for a total internal flux from 3 to 16 gas volumes per day, depending on the detector region. It should be noticed that the Muon gas system works in closed loop, recirculating tipically 90% of the gas.

Despite their different dimensions, each chamber has the same internal geometry apart from the number of gaps, as shown in figure 2. Anode planes are centered inside 5 mm gas gaps and are formed by 30 µm diameter gold-plated tungsten wires, with 2 mm spacing. The cathodes are made of FR4 fiberglass plates with two-sided 35 µm thick copper coating. In regions R1–R3 the cathodes have an additional gold coating of about 100nm. Adjacent gaps are separated by panels made of honeycomb or rigid polyurethane foam, which provide precise gap alignment over the whole chamber area. The MWPCs in stations M2–M5 have four gaps, while station M1 is equipped with two-gap MWPCs, giving a total instrumented area of about 1650 m² (counting each gap separately). The total number of MWPC gaps in the system is 4944. Each of them is powered by an independent HV channel. The corresponding pads in the different gaps of the same chamber are OR-ed in the readout .

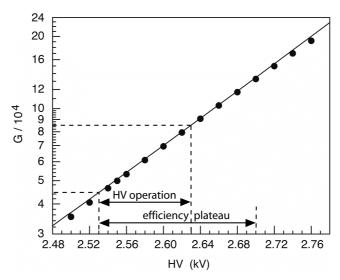
Figure 3. Gas gain as a function of HV setting in the LHCb muon MWPCs. The efficiency plateau and the HV operation range are indicated

The MWPCs are fed with a 40% Ar + 55% CO_2 + 5% CF_4 gas mixture. This mixture was chosen following studies aiming at optimizing the charge deposit and drift velocity [7]. The presence of CF4 helps the initial cleaning of the electrod surfaces and prevents the formation of Si deposits during MWPC operation. It is also a benefit to suppress ME currents, as it has been verified in the tests of chambers conditioning before installation, as described in chapter 2.1. The gas mixture is supplied into the gaps sequentially, as shown in figure 2. The HV settings, within the detector efficiency plateau, vary between 2.53 and 2.63 kV. The corresponding gas gain ranges between 4.4×10^4 and 8.6×10^4 , as shown in figure 3 [8].

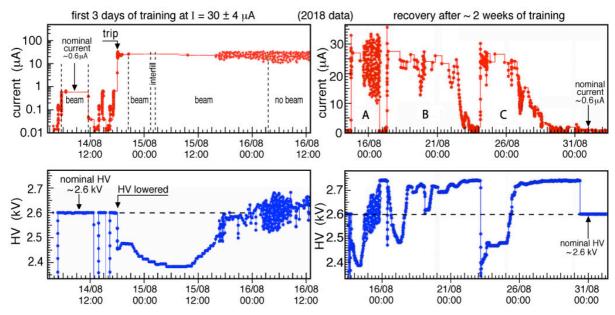
Figure 4. A typical example of the appearance of a self-sustained current and of the recovery procedure during normal LHCb operation with beams. The data refer to a gap in region M5R3. The plots on the left show the current (top) and HV setting (bottom) during a period of about 3 days around the first appearance of the HV trip and the subsequent start of HV training. The plots on the right show the current (top) and HV setting (bottom) during the full recovery procedure, which lasted about two weeks. The nominal HV setting for this gap is 2600 V; the average current in presence of colliding beams is about $0.6 \,\mu\text{A}$.

A typical example of the appearance of a self-sustained current, and the recovery procedure implemented in one of the MWPC gaps of the region M5R3 is shown in figure 4. For this chamber type, operating at a nominal voltage of 2.6 kV, the maximum current value in the presence of colliding beams is $\sim 0.6~\mu A$. As shown in the figure 4 (left), the HV channel powering this gap tripped due to the ignition of a high current exceeding the safety threshold set at 30 μA . Following the trip, a specially developed algorithm reduces the HV setting, in steps of 50 V, until the measured current is again below the safety threshold. The operator is alerted as well, who then starts the training procedure.

During the training the HV is automatically decreased, or increased up to a limit of 2.75 kV, to keep the current in a range of high but safe values ($30 \pm 4 \mu A$ in this case). The MWPC is considered recovered when the current at the maximum HV accepted for the training (2.75 kV), drops to the normal value expected at this voltage in presence of colliding beams, and drops to zero in the absence

of beams. If the same stable condition is kept for multiple days of operation with beams, the trained gap is put back in normal operation at the nominal voltage. The full recovery cycle for this gap is shown in figure 4 (right). In this particular case, after about two weeks, the self-sustained current definitively dropped down to zero. In more detail, three different cycles of recovery are visible (indicated as A, B and C in figure 4 right). The first cycle was completed in about three days, then a self-sustained current due to ME was initiated again in the presence of colliding beams, and the HV had to be reduced accordingly. The second cycle lasted for about one week, but at the end, the high current appeared again. Only after a third training period of about one week, the gap was fully recovered. The most probable explanation of this complex phenomenology is the subsequent appearance of ME in three different local regions in this particular gas gap. The probability to initiate a high current in the gap under recovery is much higher than under normal conditions, because of the higher voltage applied during training (2.75 kV), which provides a gas gain about three times larger than under nominal conditions (2.6 kV). The increased current of positive ions toward the cathode can then generate new zones where the thickness of a dielectric deposit no longer permits the full current flow from the film surface to the underlying cathode, causing an electric field sufficient to generate spontaneous secondary emission of electrons (see appendix A).

The gap taken as an example in figure 4 was recovered in a relatively short time. The average duration of the training procedure is about two months, but in some cases it requires up to four months for the full recovery. Due to that, at the end of each year of operation, we concluded with up to 25-30 individual gaps under recovery procedure at the same time. It is worth noting though, that during this long training period, the detector efficiency is only marginally affected because the other gaps of the chamber, OR-ed in the readout, are operated at the standard conditions. Moreover in the gaps under training, a sufficiently high voltage is kept for most of the time and most of the readout channels remain efficient, since the high current concerns only a localized area. For these reasons we have never been able to measure any appreciable efficiency reduction during training.

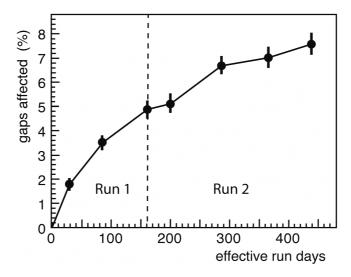
Figure 5. Accumulated fractional number of new trips observed in the detector, normalized to the total number of gaps (4944), as a function of the total number of effective run days integrated between 2010 and 2018. The values are evaluated at the end of each year of data taking. Errors are statistical.

In figure 5 the cumulative number of MWPC gaps affected at least once by HV trips, normalized to the total number of gaps (4944), is shown as a function of the total number of effective run days integrated between 2010 and 2018. The percentage of gaps affected after nine years of operation is

below 8% which reflects the high quality standards maintained during the chamber construction. The 375 gaps affected are distributed over 259, out of the 1368 MWPCs, demonstrating that most of the time only a single gap in a chamber is affected by ME. Figure 5 shows also that the curve is flattening out over the years of system operation.

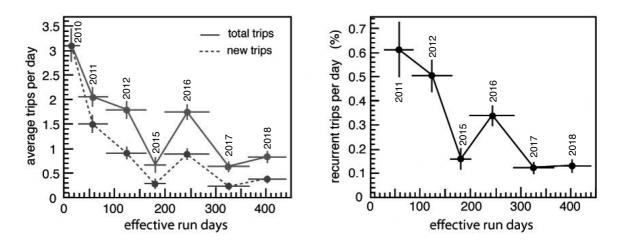
Figure 6. Left: Average number of trips per day observed during each year of data taking, as a function of the total number of effective run days integrated between 2010 and 2018; the total number of trips is shown in red (full line), the number of new trips in blue (dotted line). Right: Average number of recurrent trips per day observed during each year of data taking normalized to the total number of gaps already tripped in the past. Points are evaluated starting from 2011. Errors are statistical.

The average number of affected gaps per day observed during each year of data taking is reported in figure 6 (left) for all gaps and for the ones affected for the first time. First of all we notice that the number of gaps with recurrent trips is much higher than expected by a random effect, given the very small percentage of gaps concerned. We also notice a decreasing trend of new trips, suggesting causes originating from the construction phase rather than from ageing or other possible problems occurring during the run. An exception to the decreasing trend is observed in the 2016 run, when we suffered from a sharp increase in the trip frequency, due to a sudden significant increase of the chamber gas gain. The cause could not be fully explained, but seems to be linked to a temporary unwanted change of the gas mixture. We notice also that the two minima of the trip frequency corresponds to the two runs (years 2015 and 2017) in which the peak luminosity (and thus the chamber currents) did not exceed the values reached in previous years.

Last but not least, it can be seen that the frequency of recurrent trips remains about constant even if the total number of gaps that had a trip in the past is steadily increasing with time. This is also shown in figure 6 (right) where the number of recurrent trips per day is normalized to the total number of gaps that have already had a trip in the past. The recurrences observed during the last two years is around 0.1% per day, equivalent to less than 10% probability during the full run. This demonstrates that the adopted training procedure is effective.

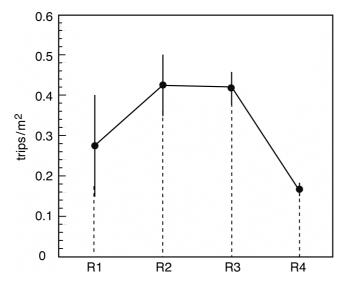
Figure 7. Number of HV trips in each region of the detector, normalized to the total instrumented area in the region, with statistical error.

In figure 7 the total number of HV trips per square meter of the detector active area, occurred in 10 years of operation, is shown separately for the four regions exposed to a particle flux per unit area strongly decreasing from R1 to R4. Despite the large statistical errors affecting the values in regions R1 and R2, based on 5 and 33 events respectively, the expected decrease with the radiation dose from region R1 to R3 seems to be contradicted. This is certainly due to the different treatment to which the chambers have been subjected. In particular, as discussed in section 2, most of the chambers of the inner regions R1 and R2 passed before installation through an additional step of the training procedure under irradiation at the GIF, which strongly reduced the trip probability during the following runs at LHC. Conversely the drop of trips in region R4, as compared to region R3 seems to follow the expected behavior, given by the reduced irradiation. In this case however, the observed trend could also be influenced by the better initial cleaning of the R4 gaps as mentioned in chapter 2.1

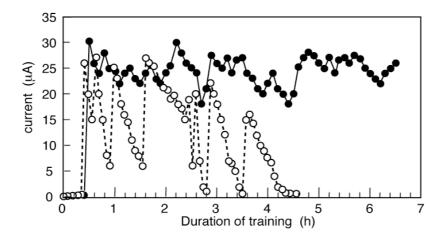
Figure 8. Current in the MWPC during the ME recovery training: nominal mixture (full circles) is compared with a mixture containing 2% of oxygen (open circles).

For each of the above zones, a recovery training as the one described in section 3 was first tried for few hours with the standard gas mixture in order to confirm what was observed on the apparatus. Then a new training was performed with a new gas mixture, adding $\sim 2\%$ of oxygen to the nominal one. In all cases the concerned area was kept under irradiation by the 90 Sr β -source. Figure 8 shows the results obtained for one of the gaps. With the standard gas mixture no current decrease is observed after more than 6 hours, consistent with what was obtained in the training with colliding beams. In the presence of oxygen, however, the initial current of 25 μ A (initiated at the voltage of 2.6 –2.7 kV) drops sharply until it rises again in correspondence with a voltage increase carried out to maintain a high current level. After a few iterations the current finally drops to zero. The total time required to recover the ME zone in this case was around four hours. Similar results were obtained for all zones affected by ME, as listed in table 3. After the training with oxygen, all of the MWPCs above have been installed back on the apparatus and worked properly, with no recurrent trip during the full Run 2 of the LHC.

The above tests confirm the hypothesis of an accelerated recovery procedure in presence of oxygen [12], based on plasma chemical etching of silicon and organic compounds by electronegative active radicals and ozone produced in the gas discharge, as discussed in appendix B. Volatile compounds created during the etching are then removed by the gas flux. The amount of oxygen added to the mixture must be small because the electronegative nature of oxygen reduces the electron density in the discharge plasma resulting in the reduction of the charge amplification. By adding 2% of oxygen, the gas gain decreases by a non negligible amount of about 20%, but is still sufficient to support a relatively high current for an effective etching in the recovery process. A small amount of oxygen could be added in the future to the working gas mixture during the year-end-technical-stops, either for targeted recovery interventions, or for conditioning while exposing the chambers to a high intensity radioactive source. Also a permanent use during detector operation of a gas mixture with small amount of Oxigen could be envisaged and fine tuned.

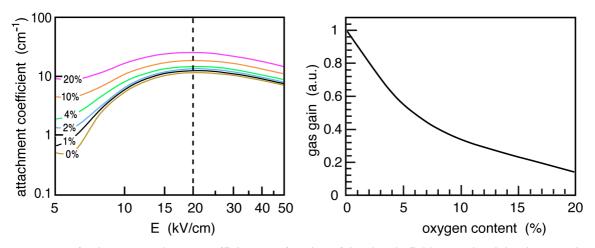
Figure 9. Left: electron attachment coefficient as a function of the electric field strength. Right: the gas gain as a function of the oxygen content.

However, O₂ content in MWPC working gas mixture should be strongly limited. In fact, due to its high electron attachment coefficient, the oxygen reduces the electron density in the discharge plasma. This results in the reduction of the charge amplification. Thus to keep the gas gain at the level sufficient for the recovery process, the oxygen content should be optimized.

To find the optimal amount of oxygen to be added to the working gas mixture, simulation studies for the muon detector MWPCs have been performed using the GARFIELD software package [20]. The results of the simulation are shown in figure 9. The electron attachment coefficient as a function of the electric field strength is shown in the left plot. The right plot shows the gas gain dependence on the oxygen content, where the latter is added to the standard 40% Ar + 55% CO2 + 5% CF₄ gas mixture.

As a result, for 1-4% O_2 content the electron attachment coefficient increases substantially only in the drift region, especially near the cathode surface, where the electric field strength is about 6 kV/cm. Conversely, when oxygen content exceeds 10%, a noticeable electron attachment occurs throughout the whole drift path and the avalanche region. As a result, the MWPC gas gain at the operation voltage would drop by more than 60%, too much to be compensated by an increase of HV sufficient to support an effective etching process. In the test of accelerated recovery of the MWPCs a percentage as small as ~2% of oxygen was added to the nominal gas mixture and satisfactory results were obtained.
